Project Silent
ANZAC

Preliminary
Analysis of
Imagery Data

February 2015

Preliminary Analysis of Imagery Data arising from the 2014 Internal Investigation of HMAS AE2

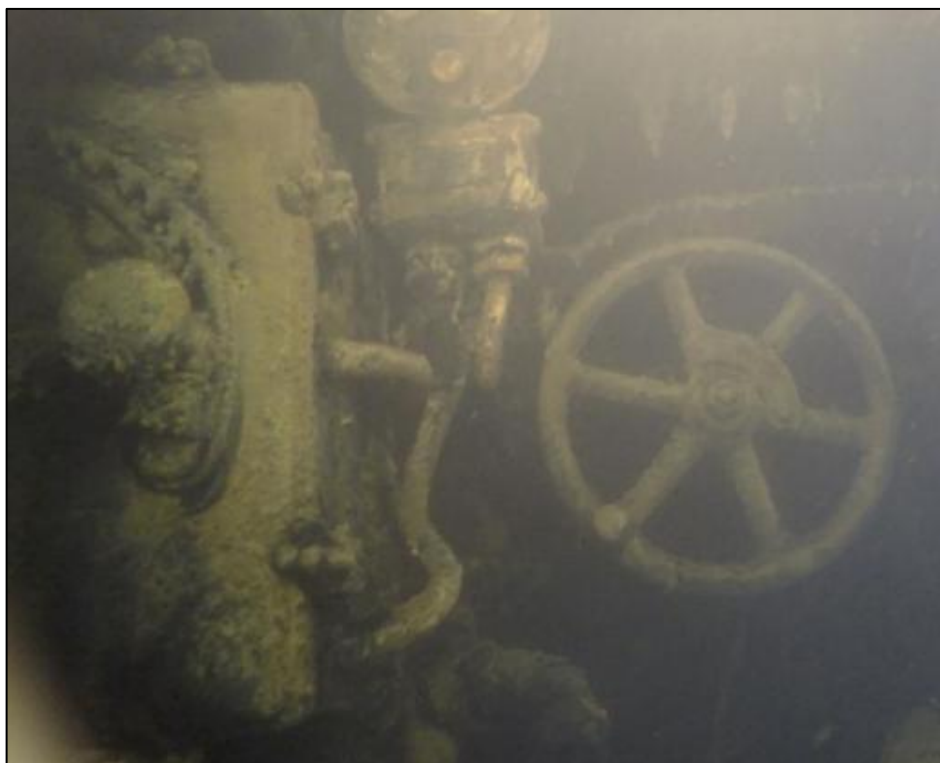
Figure 25 - The First Image Recorded by the DSTO ROV from inside the Control Room

(It shows the starboard ballast pump control slide, a Kingston wheel and a pressure gauge.)

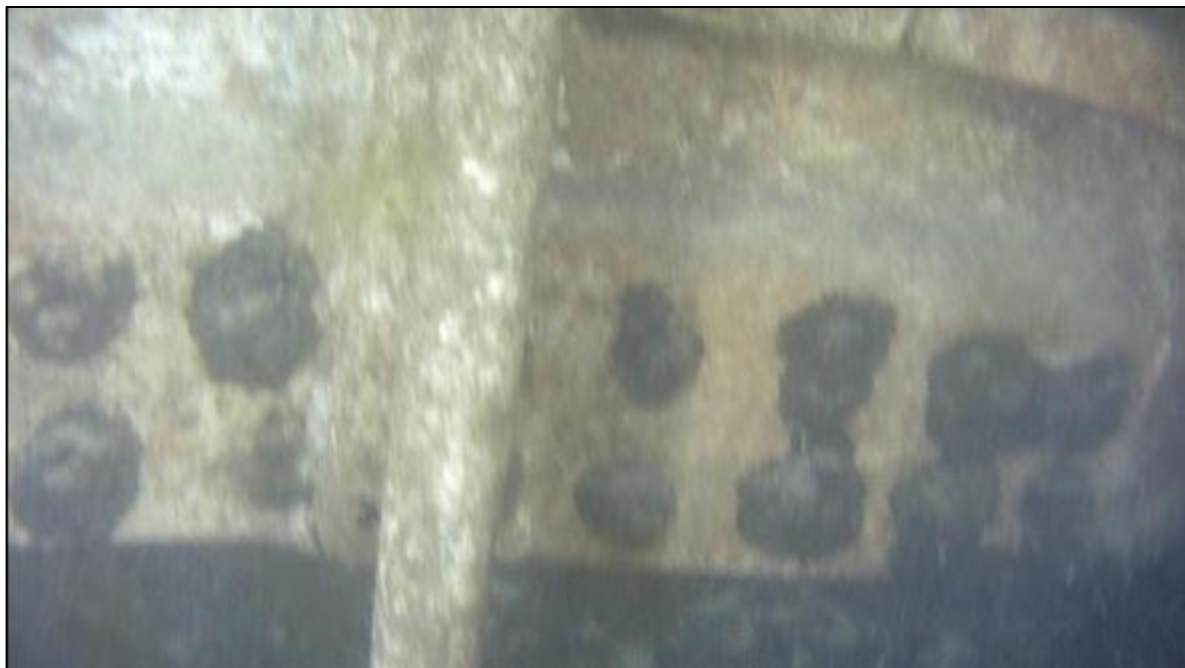
Figure 32 - This Image shows the Twin Lines of Rivets that join the Two Parts of the Conning Tower

It was known that the upper portion of the conning tower was cast out of non-ferrous material and that the lower half was steel. A matter of considerable interest to the science team was to investigate how well the interface between the two parts of the conning tower had survived. As early as 1763 the Royal Navy frigate HMS *Alarm* had been used in an experiment on the use of copper sheeting for antifouling, with the result that iron fasteners were rapidly lost to corrosion (6). Clearly, in the case of AE2, the rivets joining the two parts of the conning tower have been carefully isolated from the brass, as they are still appear to be quite sound.

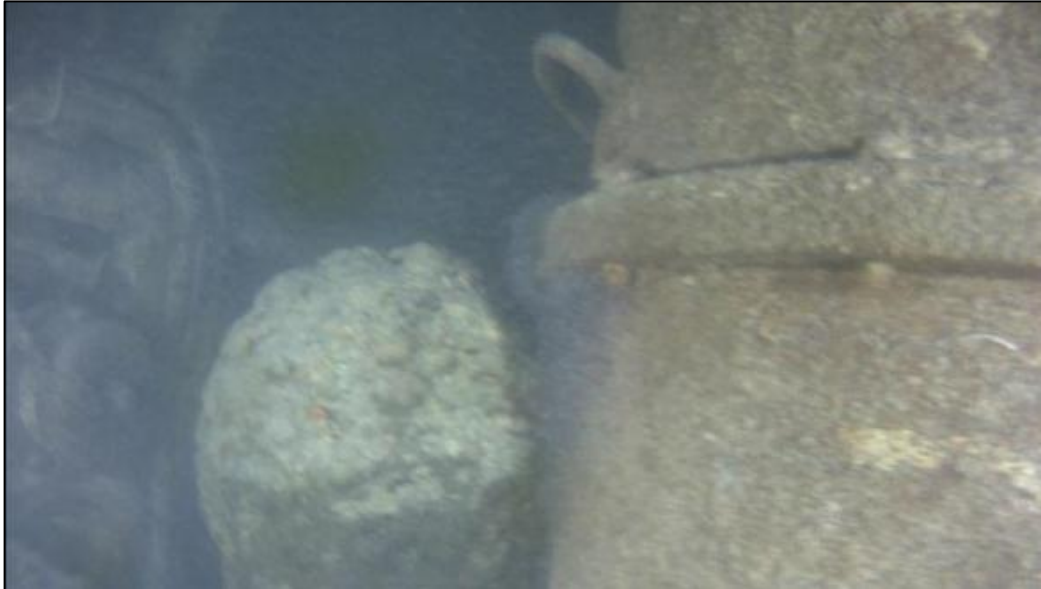
Figure 33 - The Portside Soft Iron Sphere adjacent to the Housing for the Magnetic Compass

The magnetic compass was mounted high up in the conning tower, where it was clear of ferrous metals. This compass is in good condition, it still has the soft iron spheres on either side of it and the light pipe, leading to the lower helmsman's position in the control room, is still in place.

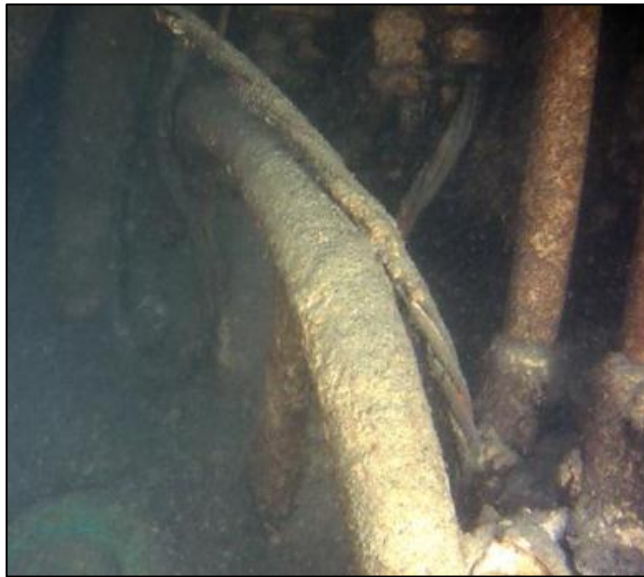
Figure 36 - The Two Parts of the Bridge Steering Wheel are stored in the Conning Tower

(Note the spokes of the wheel. The cable lying on the rim of the wheel is three-core electrical cable, with insulation still relatively intact.)
