## Technical Meeting – 2 September 2020

Sean Langman, Managing Director of Noakes Group, gave a presentation on *Ferry Radar Preservation: a Link to a Once-working Harbour* as a webinar hosted by Engineers Australia with Phil Helmore as MC on 2 September. This presentation attracted 70 participants on the evening.

Sean began his presentation by saying that the Rosman ferry *Radar* has been restored to full working order, and will comply with all AMSA's NSCV requirements.

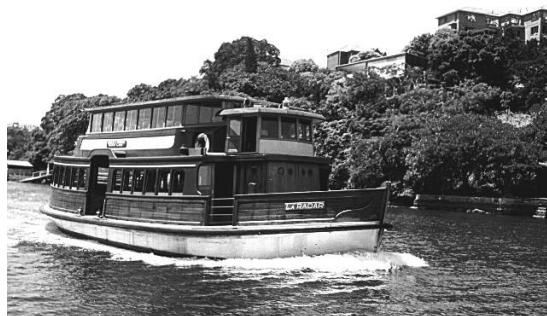
*Radar* with top deck enclosed in 1955  
(Photo courtesy Noakes Group)

*Radar* had the top deck enclosed by about 1955. However, the stability book had not been updated since she was built! Noakes have therefore had to go through everything. They have lowered the centre of gravity from this photo, and therefore have betterer stability characteristics. Due to the refit construction, the vessel will not have any bilgewater, and so there will be no unaccounted free surface effects.

The sponson band always rusted and, in the photo, you can see rust streaks below the sponson on the white topsides.

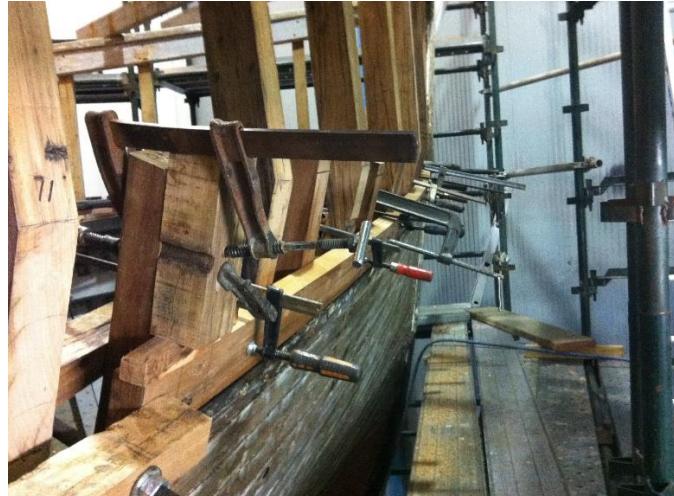
*Radar* sponson refit in 2013  
(Photo courtesy Noakes Group)

*Radar* had been well built, with hardwood planks and frames. The decks were planked with teak which Charles Rosman had obtained from HMAS *Adelaide* for the decking on the ferries *Radar*, *Regal* and *Royale*. However, the teak decks were attacked by corrosion of the steel dump-spike fastenings, and the hardwood sponsons and stanchions were attacked by corrosion of the steel rod fastenings; other fastenings in the vessel were bronze and copper. Under the deadwoods was a lead shoe, which had been cast on site.

*Radar* came into Noakes' yard in 2013 to have her sponsons replaced. However, when they removed the sponsons, they found electrolytic rot had affected the stanchions as well. The planned sponson refit turned into a seven-year refit of the whole vessel!

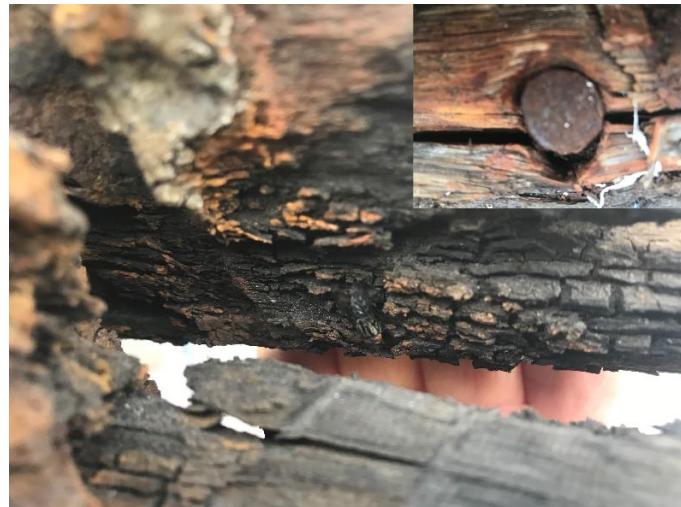
Electrolytic rot  
(Photo courtesy Noakes Group)

Steel is a ferrous metal and corrodes. The insert in the photo shows a halo of corrosion around the steel fastening. As the electrolytic current passes through the corrosion, it degrades the timber. Timber vessels are living things, and react to their environment and electrolytic rot. The sponsons on small monohull ferries are wide so that, when they come alongside wharves and roll, their superstructures don't hit the wharf. The refit started with the sponson band but, when removed, they found that every single stanchion behind the band was affected by electrolytic rot, and the topmost planks had also been degraded, so that the superstructure had separated from the primary ribs and stringers. The refit escalated!

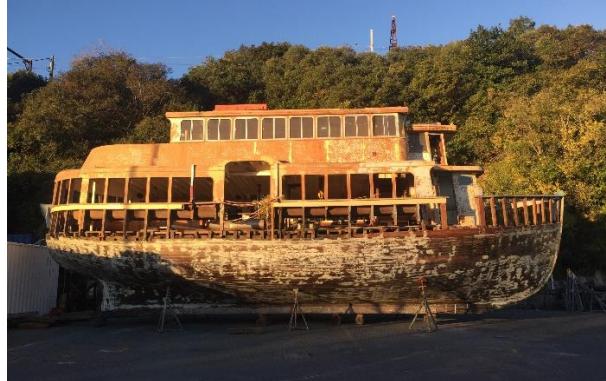
Radar refit in 2019  
(Photo courtesy Noakes Group)

When removed from the water, the vessel had a significant hog in her keel (visible in the photo). They made the sheer line look OK and, with the conversion from wet-wood to dry-wood construction (of which, more later), she has ended up with a slight hog.

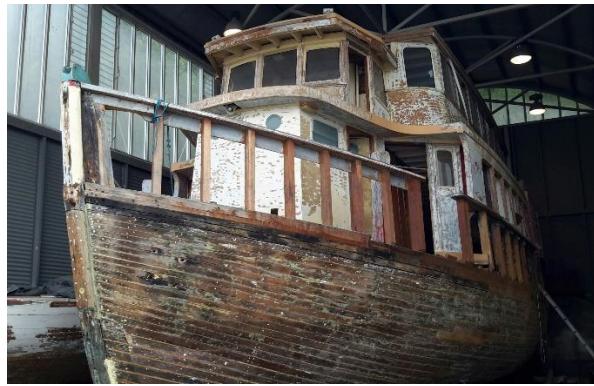
*Radar* in the shed  
(Photo courtesy Noakes Group)

So they moved *Radar* into the shed. The top two planks in the photo are showing the extent of the electrolytic rot, looking like charred patches where the sponson band came off.

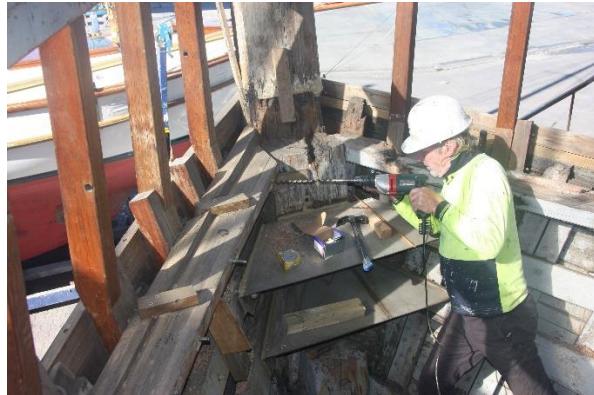
Foredeck work on *Radar*  
(Photo courtesy Noakes Group)

The stanchions all had to be replaced, and here the boilermaker is boring a hole for a 316 stainless steel fastening. They would have preferred to put laminated timber frames in the bow but, having to work to a timeline, they ended up putting stainless steel frames in the bow section. Also visible in the photo is the massive stempost.

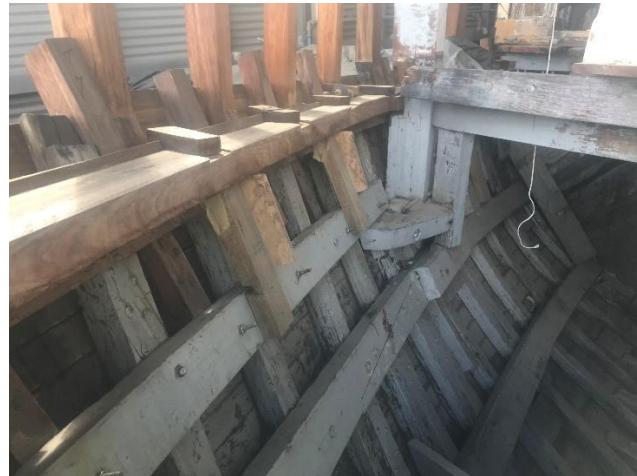
Internal structure on *Radar*  
(Photo courtesy Noakes Group)

The photo shows the new deck clamp, the ribs and the fore-and-aft stringers, all bronze fastened, with roved copper nails holding the planks.

They ended up changing the structure of *Radar* from wet wood to dry wood construction. In wet wood construction, the planks are stacked on top of each other and, on the outside, the seams are caulked with oakum and/or cotton, hammered into the seams with a caulking iron, then payed with putty. When back in the water, the timber swells with the water and tightens on the cauking in the seams.

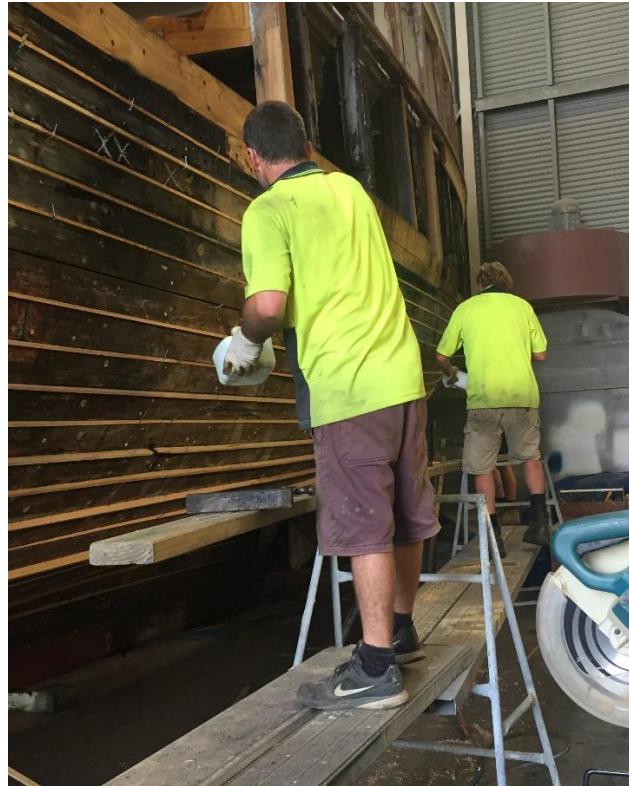
Splining between *Radar*'s planks  
(Photo courtesy Noakes Group)

They deliberately left *Radar* out of the water for a long time to completely dry the timber for the change to dry wood construction. They then ran a spline saw down each seam to remove all oakum and/or cotton, tar, read

lead, etc. The seams were painted with Everdure, and then gluefibre mixed with a high-temperature epoxy payed in, and a softwood spline driven into each seam. This gives a monocoque external shell, and the internal ribs, stringers, etc. are just coming along for the ride.

The big problem is the interface of the garboard planks with the keel. The rabbet has been adzed out on each side of the keel, and the edges of the garboard planks fit into it. However, the slight hog in the keel means that the rabbet is no longer in a straight line and the garboards don't have a perfect fit. They ended up having to back-fit from the inside, using silicon-bronze screws, rather than twisted copper boat nails, so she is not all rove fastened. The planks were glued onto new ribs, and so there is a combination of new and old methods. This gives low maintenance and a longer lifespan.

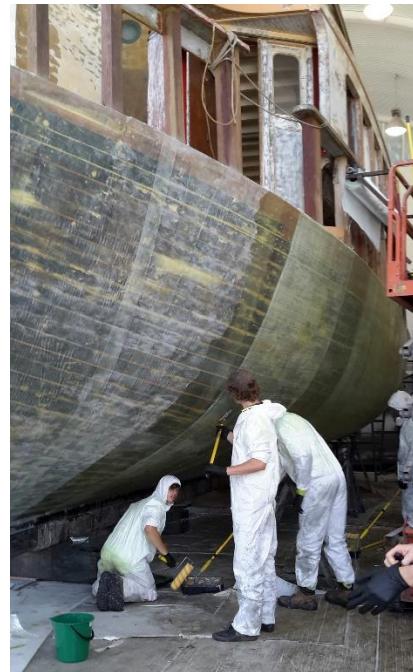
Sheathing *Radar*'s hull with GRP  
(Photo courtesy Noakes Group)

The monocoque shell is sheathed on the outside to ensure the total exclusion of water, but the GRP sheathing does not gain any structural credit.

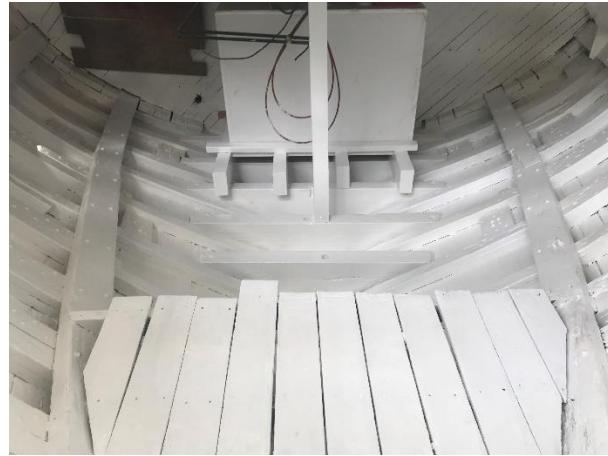
Forepeak on Radar  
(Photo courtesy Noakes Group)

The tank in the background of the forepeak photo is the black-water tank. The only access to the forepeak is through a watertight bulkhead, and they have painted the whole of the compartment gloss white with an epoxy finish. All seams were done with a large brush, keeping the water out. If the compartment filled with water, the water would find its way into the timber which would swell and could lead to failure. They have sufficient layers of GRP to cope, and so this will be OK, and they will have no internal free surface from bilgewater. The athwartship floors down low are through-bolted to the keel and help to support the garboard planks (so that there is no flexibility) and to transfer the loads upwards.

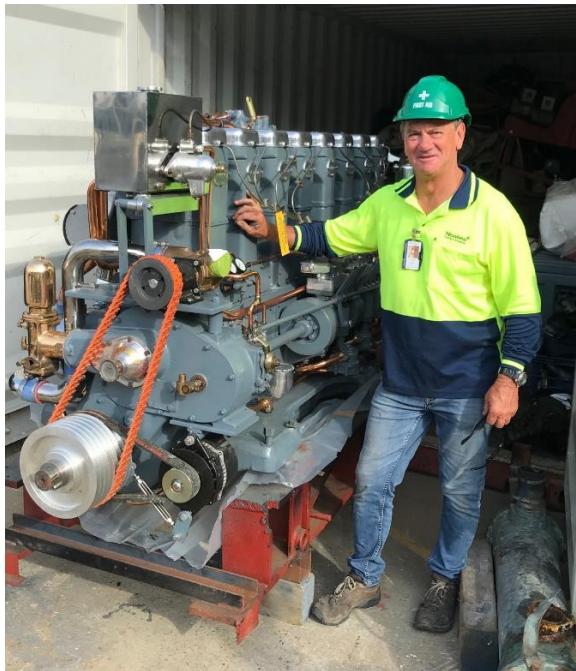
Sean with the overhauled Gardner 8L3B  
(Photo courtesy Noakes Group)

Sean really enjoyed this refit, because of the engine in particular. *Radar* was originally fitted with a Gardner 8L3 engine. However, they had numerous Gardners onsite, and they picked an 8L3B which is basically the same as the 8L3, but 40 years newer and has 50 hp (37 kW) more power. They sent several engines to Dave Shaw of Shaw Diesel in Auckland, New Zealand, for overhaul, and he did a fantastic job on them.

There are few changes to the engine from original, except that the engine controls are better and, to fulfil safety requirements, they had to fit various guards.

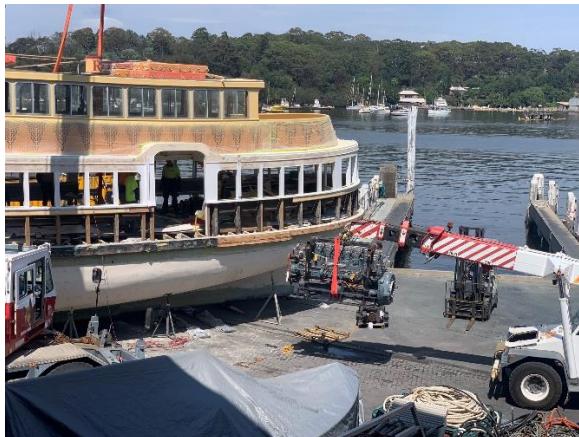
Reinstalling the engine  
(Photo courtesy Noakes Group)

To reinstall the engine in the vessel, they had to build a special lifting frame to go through the side entry and down through two decks. Sean, being a rigger by trade, loved this bit! In the reinstallation photo, you can see the marriage of different timbers on the sponson band; some original and some new oregon.

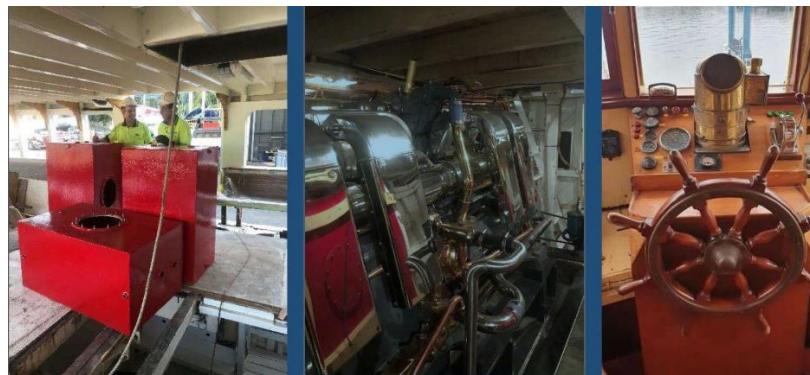
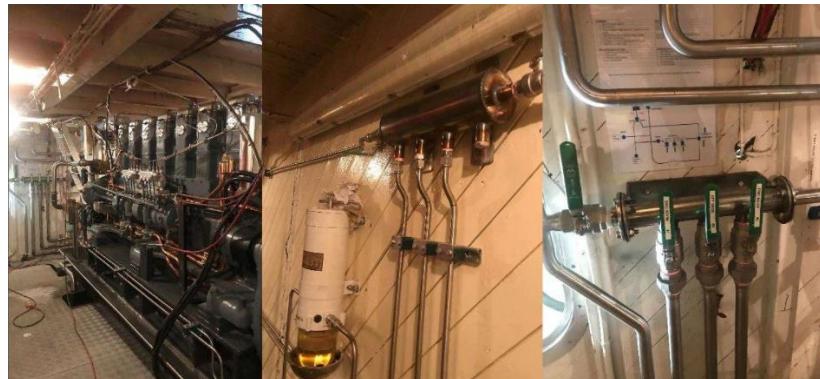
Mechanical works on *Radar*  
(Photos courtesy Noakes Group)

More mechanical works on *Radar*  
(Photos courtesy Noakes Group)

All mechanical works on board are to AMSA's NSCV requirements. They went to the trouble of fitting stainless steel pipework for longevity. The Gardner engine sits in a stainless steel bath which captures everything, and nothing goes into the bilge. The old adage used to be that you never had to do an oil change on an English engine, you just kept pouring oil in! The original concrete ballast was left in the bilge, and everything went in over the top.
