# **VENTILATION & HABITABILITY IN AN OLDER R.A.N. SHIP PROBLEMS & SOLUTIONS**

**CMDR. B.L. SWAN, C. ENG., M.R.I.N.A.**

Commander B.L. Swan, C.Eng., MRINA.  
Command Technical Officer on the staff  
of the Flag Officer Naval Support Command.

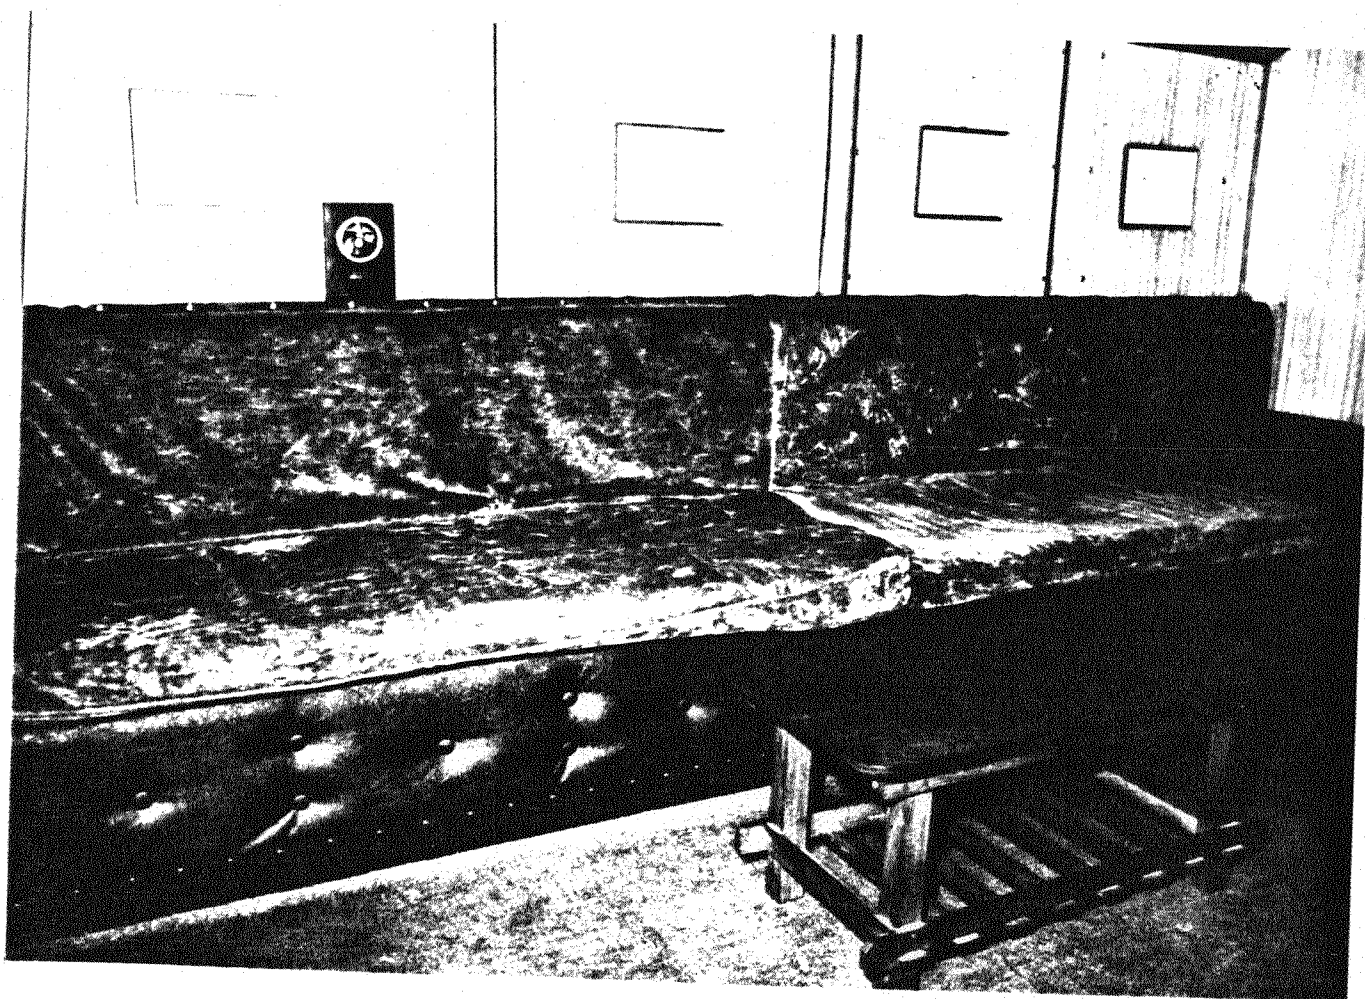
4J CPO/PO MESS

A self help project showing fully pannelled bulkheads and deck hand, carpeted deck. Ample stowage exists under the side bench.

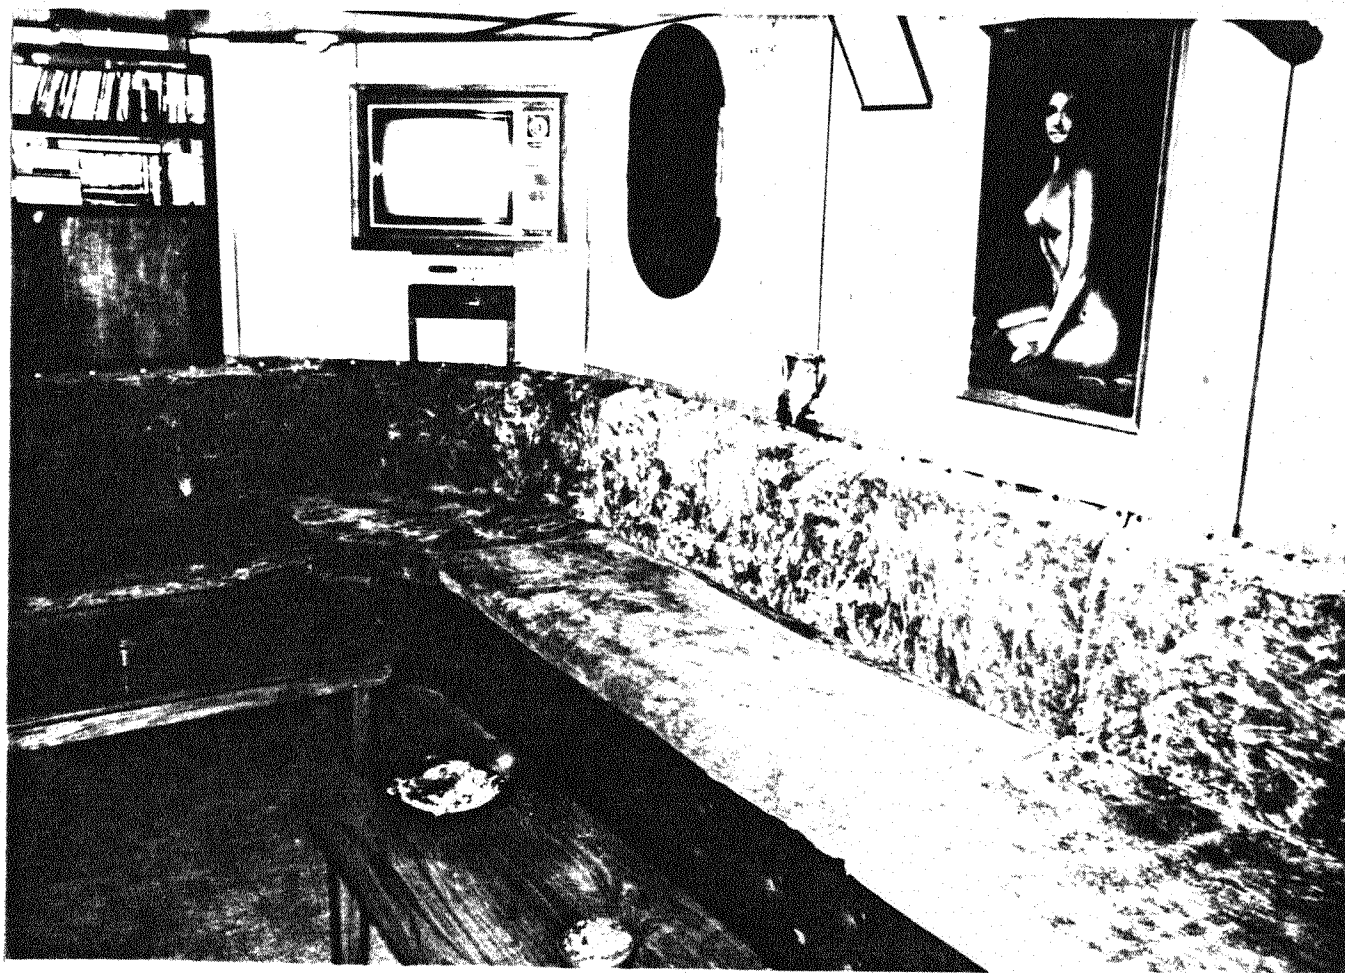
4J CPO/PO MESS

A view of the opposite side showing the built-in TV set and stereo system. Cussions made onboard were covered by the dockyard.

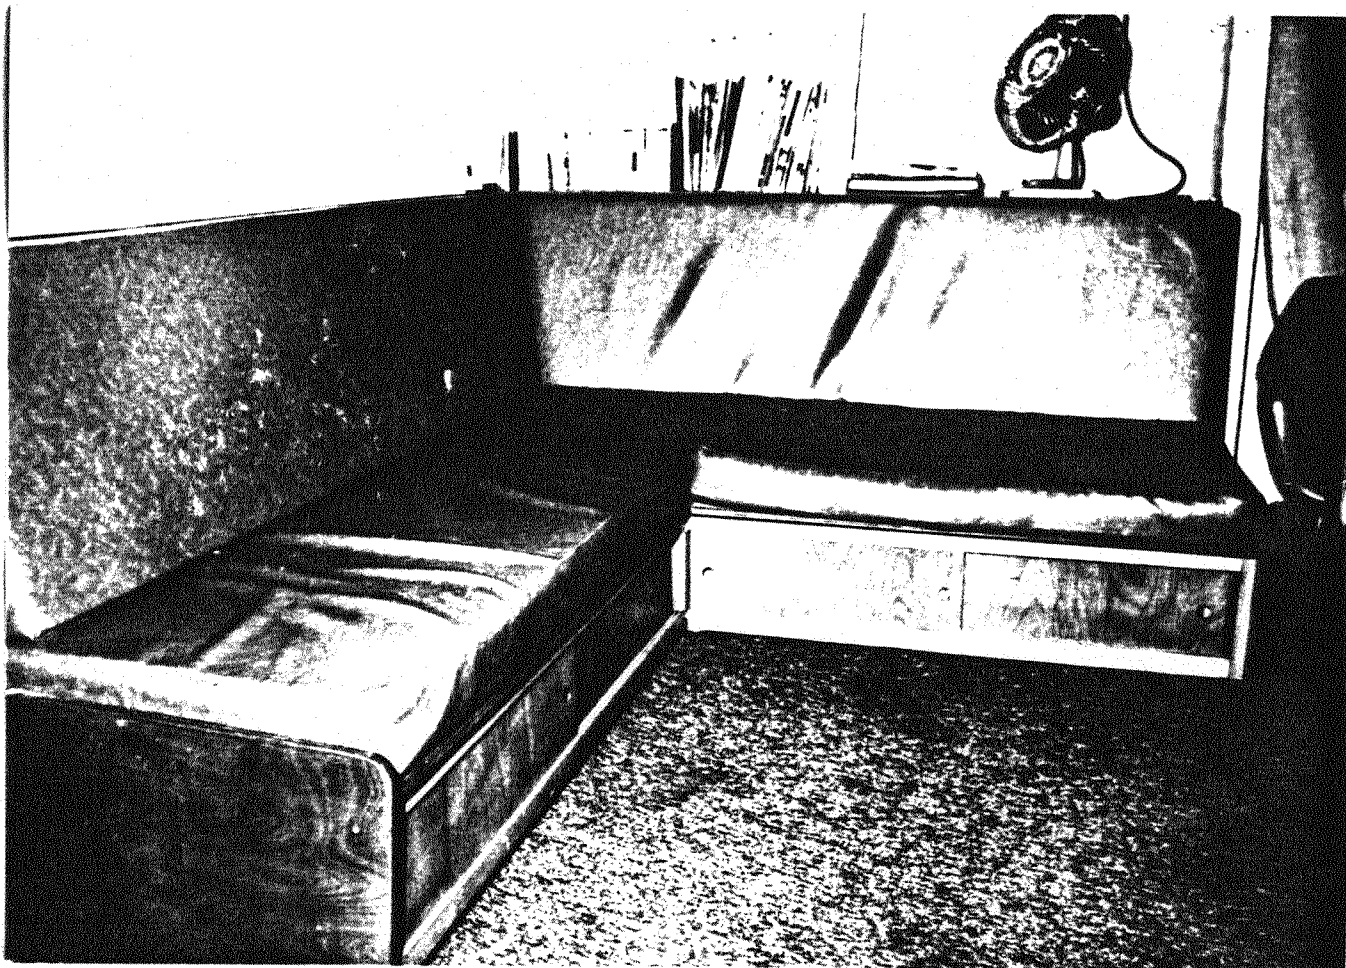
4P POs MESS

A self help project converted from a junior officer's cabin to provide additional areas for senior sailors.

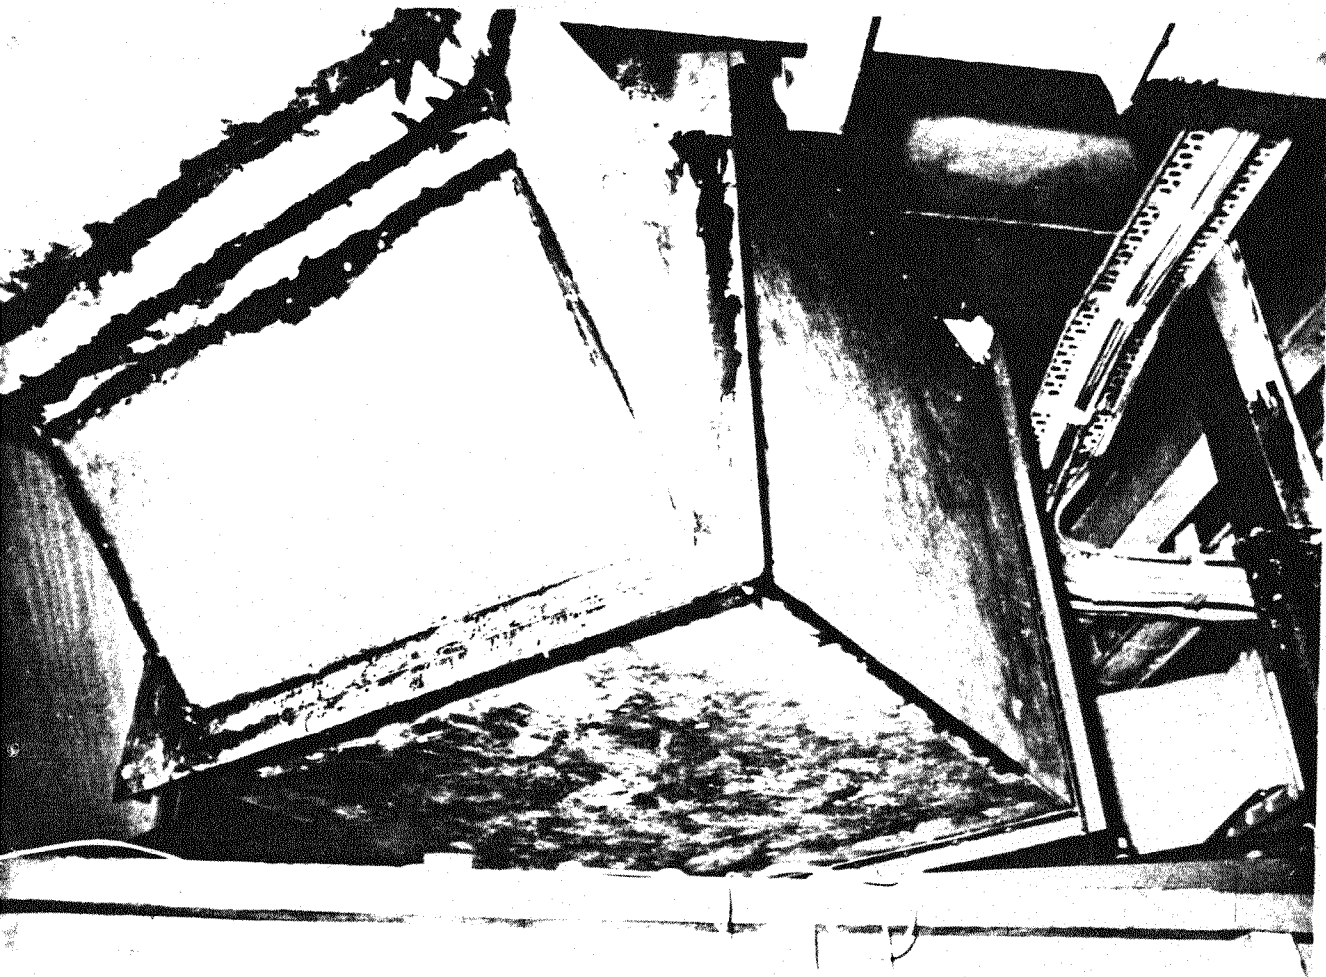
3M PORT MESS WEATHERMAKER

Installed by contractors to provide cool air to a sailor's mess, this unit made a significant improvement for watch-keeping personnel.

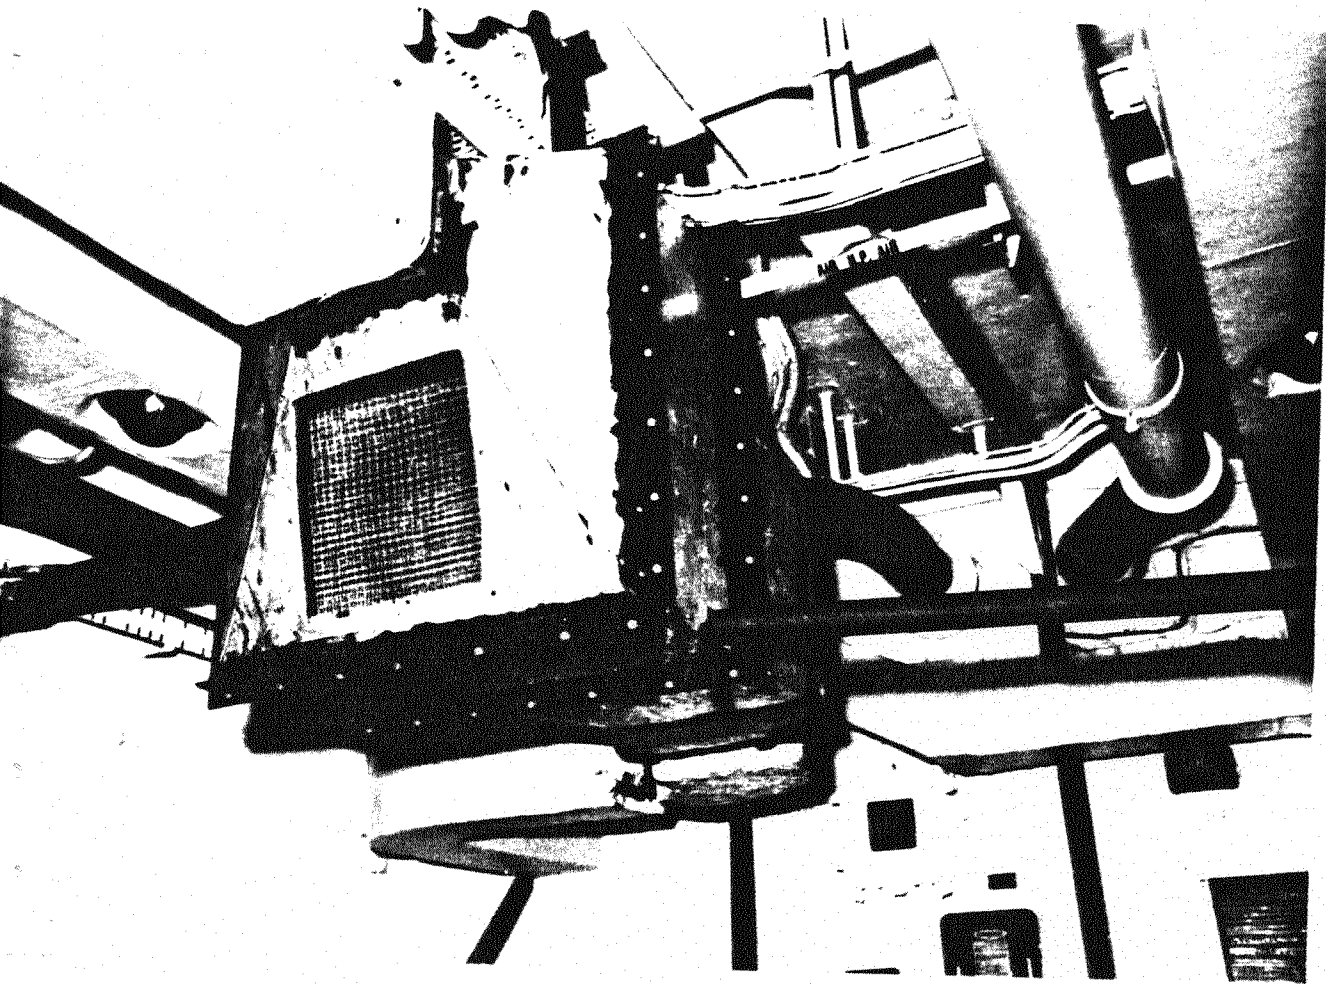
2J BRIDGE MESS WEATHERMAKER

Fitted by contractors to provide cool air to the Bridge Mess,  
this is perhaps the most awkward arrangement - but it works!

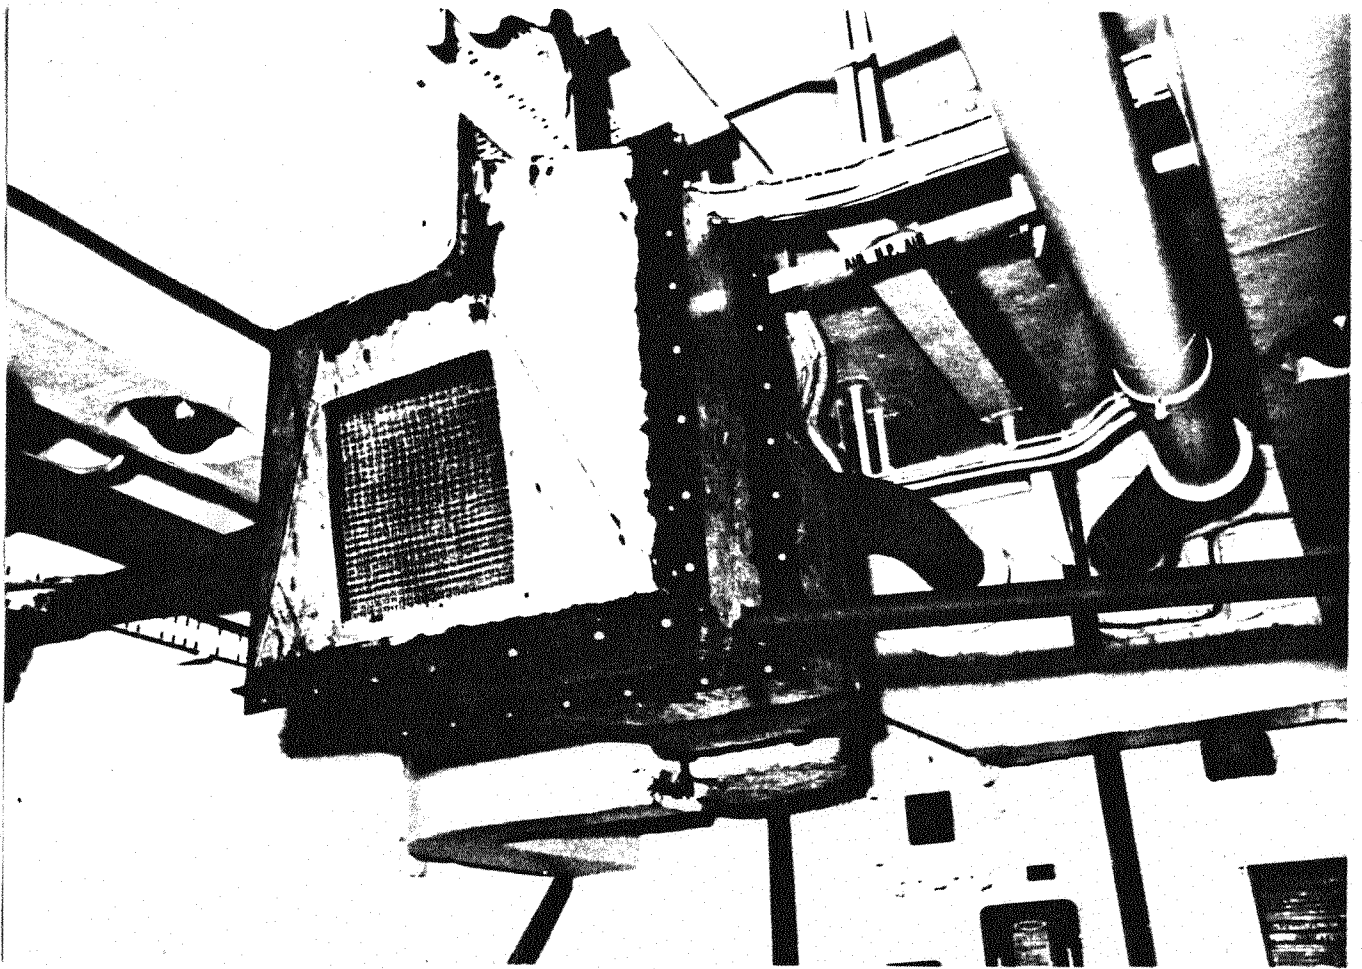
2J BRIDGE MESS WEATHERMAKER

Fitted by contractors to provide cool air to the Bridge Mess,  
this is perhaps the most awkward arrangement - but it works!

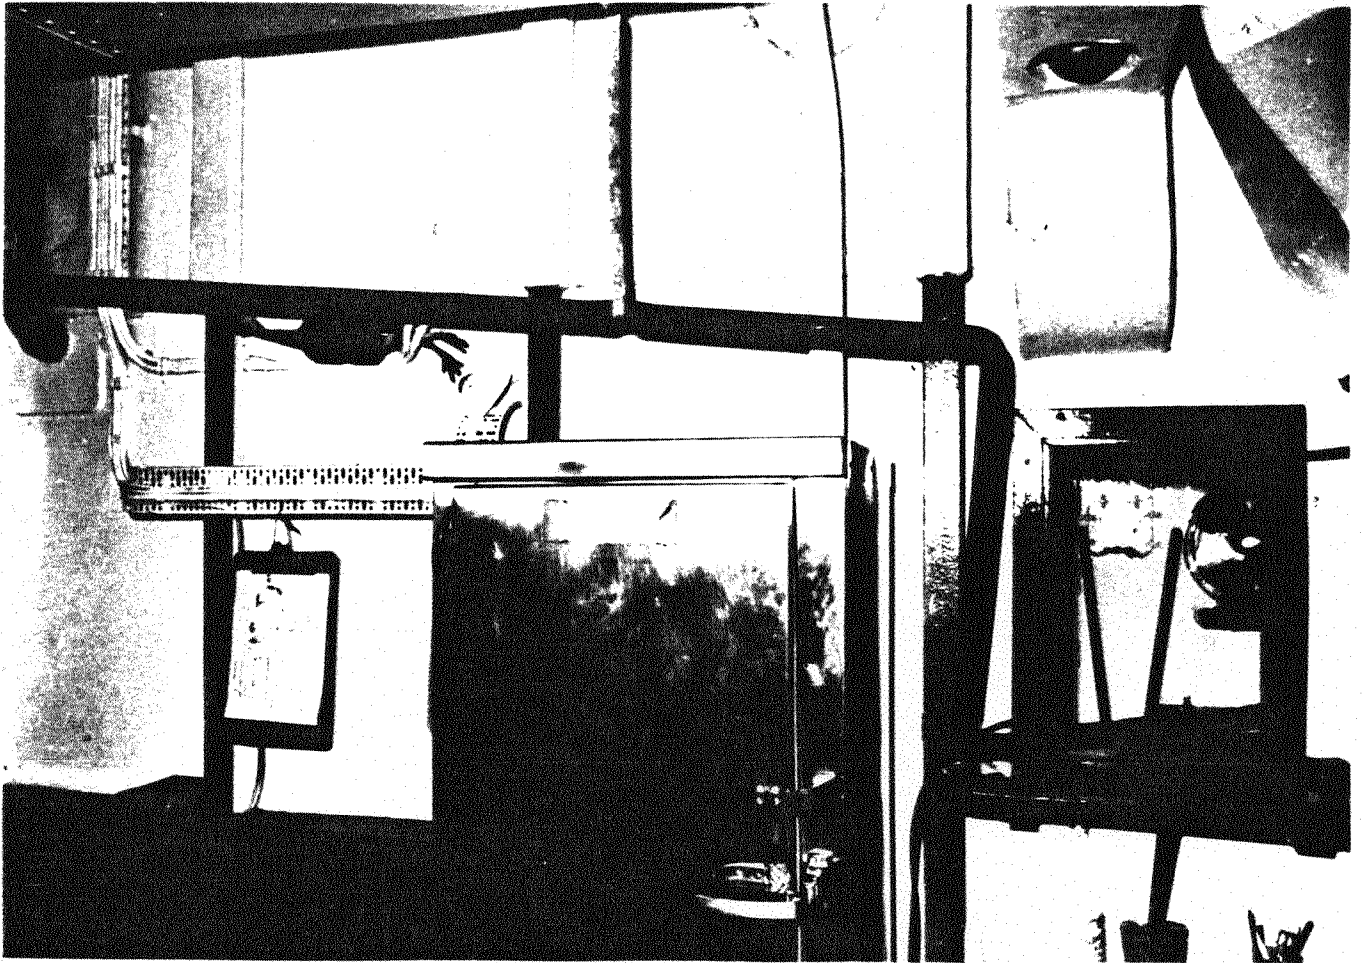
2J BRIDGE MESS

Note the awkward drain arrangement from the weathermaker :  
for every gain there is a loss.

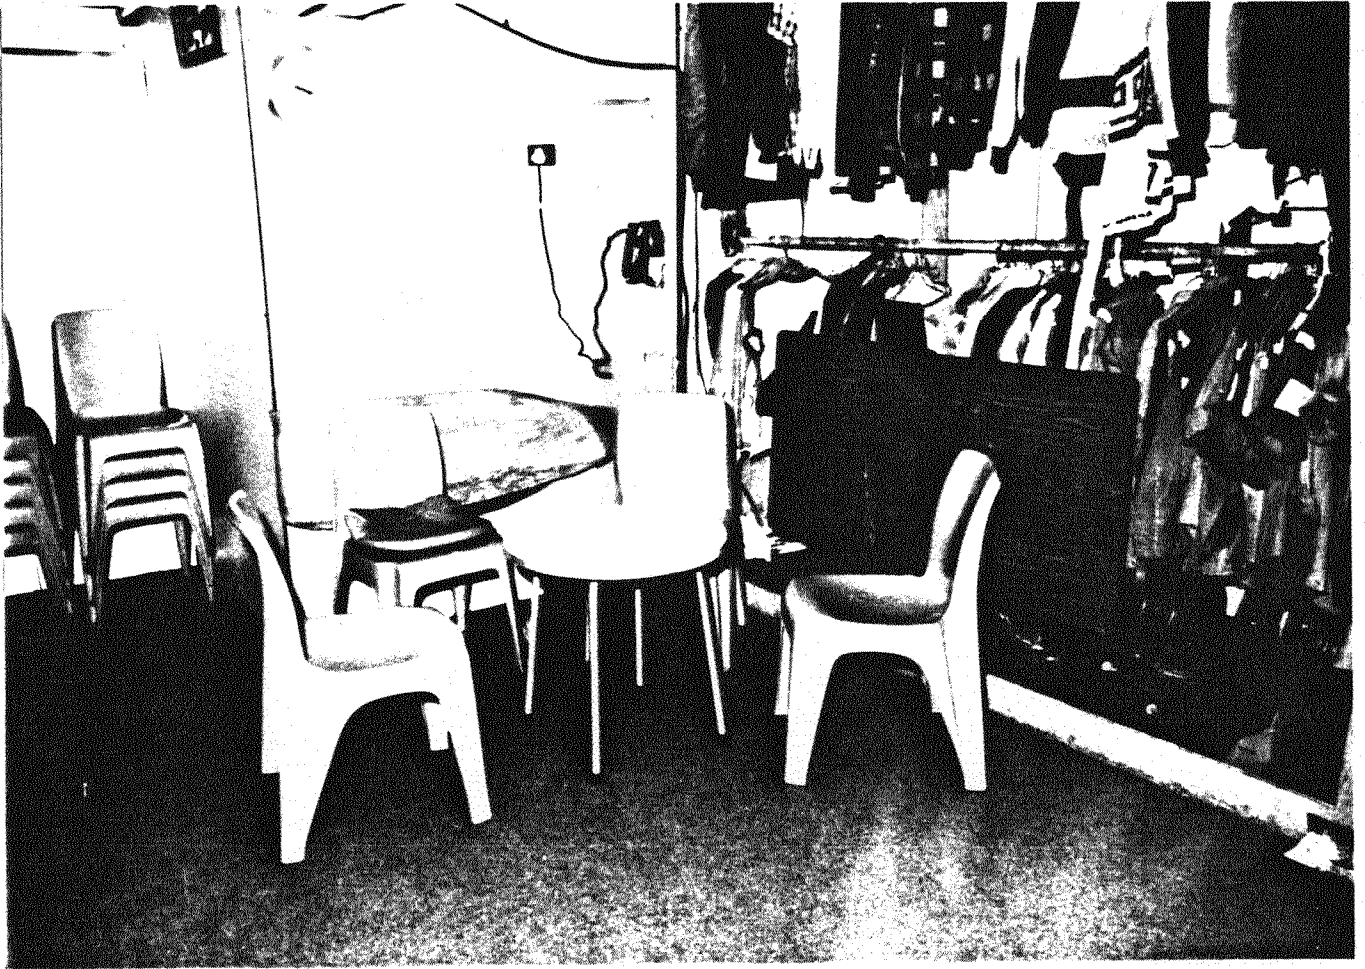
4N ELECTRICAL MESS

A panelled recreation area, carpeted deck and additional hanging space all by self help.

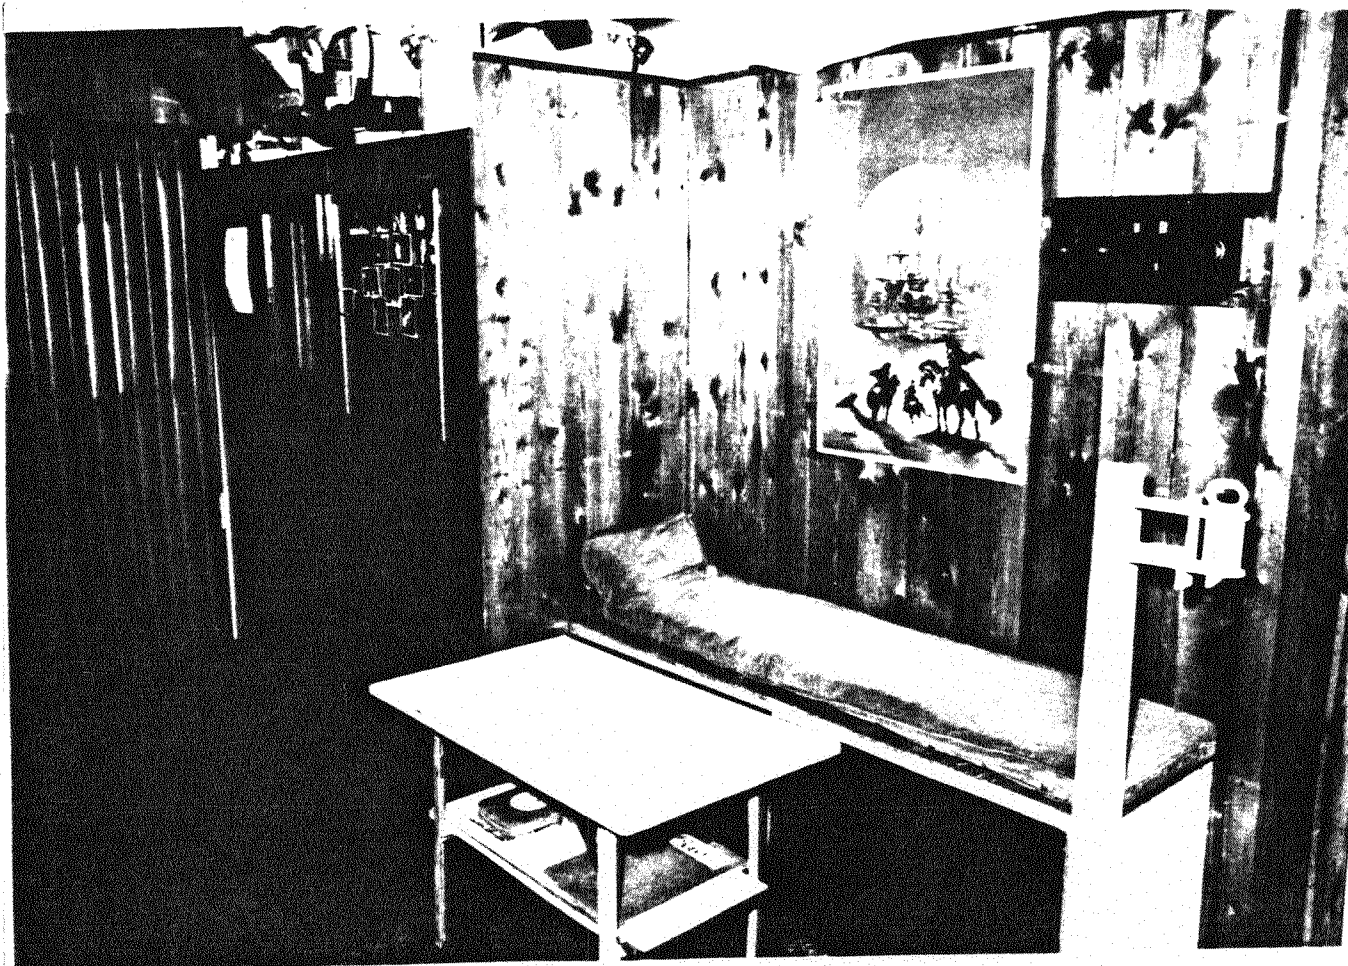
3D PORT MESS

Panelling, concertina door, carpet and built-in stereo - all self help in a mess that used to be a main passageway.

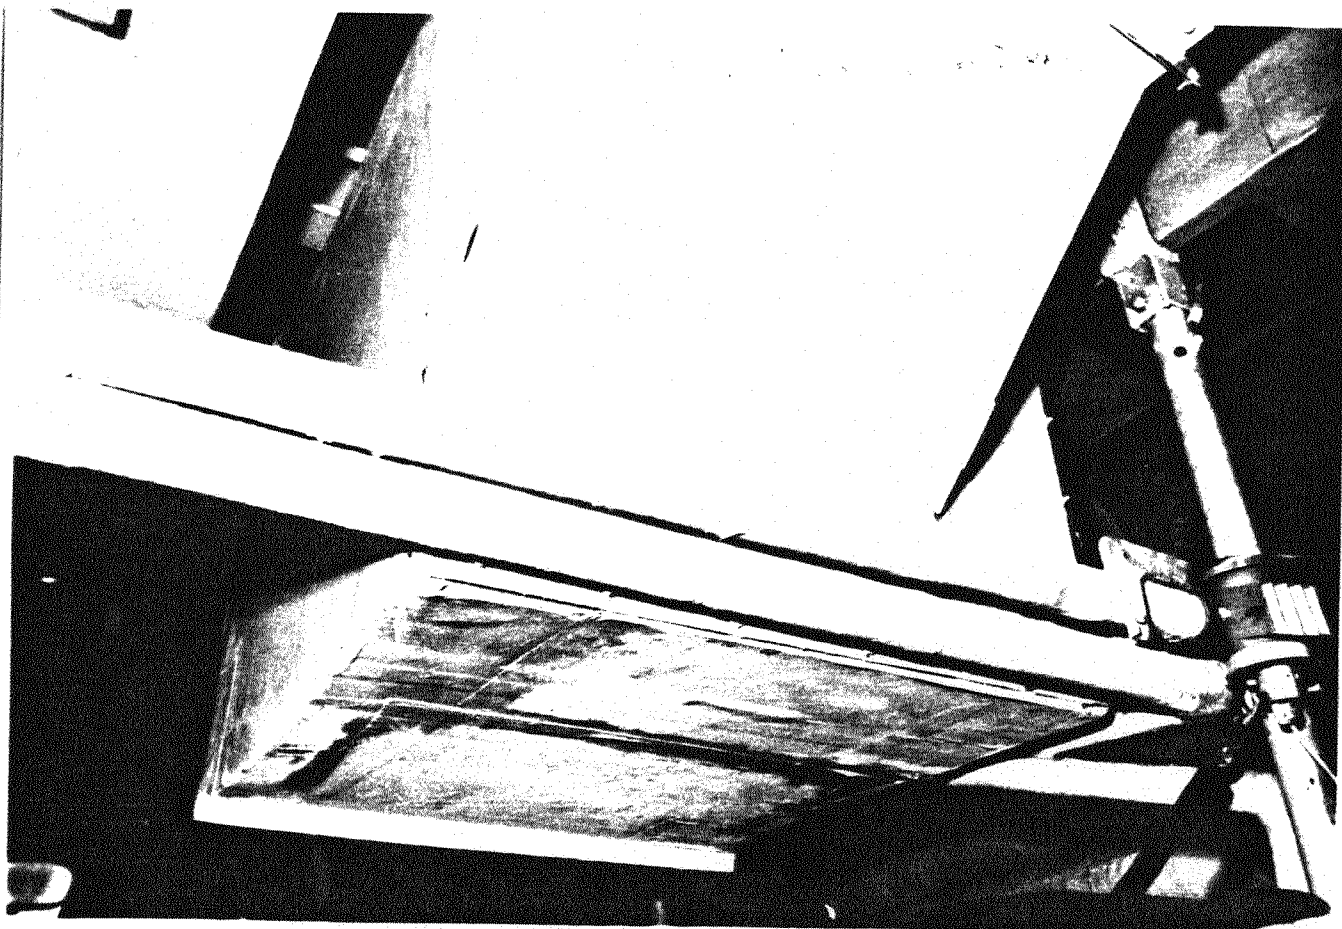
3D PORT MESS WEATHERMAKER

Installed by contract to provide cool air to a sleeping compartment which was previously non-air conditioned.
