OBSERVATIONS FROM THE SHOCK TRIALS OF THE INSHORE MINEHUNTERS.

The Inshore Minehunter (MHI) HMAS Shoalwater is the first (and so far only) naval vessel to be shock trialled within Australia. The conduct of this trial, where the fully crewed and operational vessel was exposed to severe underwater explosions, was the outcome of many years planning within the RAN Design Branch. The first part of the paper gives an overview of the phenomena of underwater shock and the work which goes into designing a naval vessel to it. Mention will then be made to the way these rules were applied during the design of the MHI. The second part of the paper will then review the process of shock testing which was applied to the MHI to ensure that the vessel met its specified shock requirements.

1. The Royal Australian Navy is currently evaluating a new class of inshore minehunters (MHI) designed by the Naval Engineering Services Branch. To fully evaluate the design of these vessels, two prototypes have been built. One of the major milestones of the evaluation period was achieved with the successful shock trialing of the second of the two prototypes, HMAS SHOALWATER. This trial which took place at Halifa

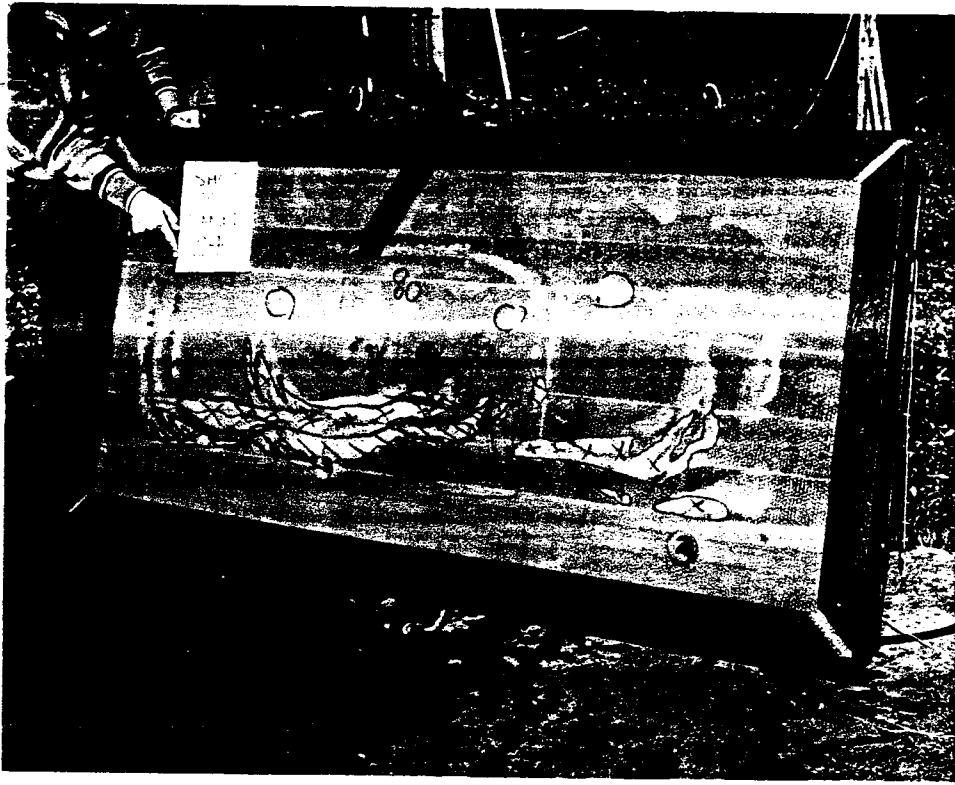
FIG 1 : FLAT TEST PANEL

3. Initial shock trial work centred on proving of GRP and foam sandwich hull materials would meet the RAN's specified shock requirements. To this end a series of small flat panel shock tests were commenced in 1977. Fig 1 shows typical details of the flat panels and their testing method. In all, 38 panels were tested. The initial panels in this series were used to evaluate different types of materials, and the later panels to investigate materials from different manufacturers and construction details. These panel tests provided useful data at relatively low cost, and in a quick timescale.

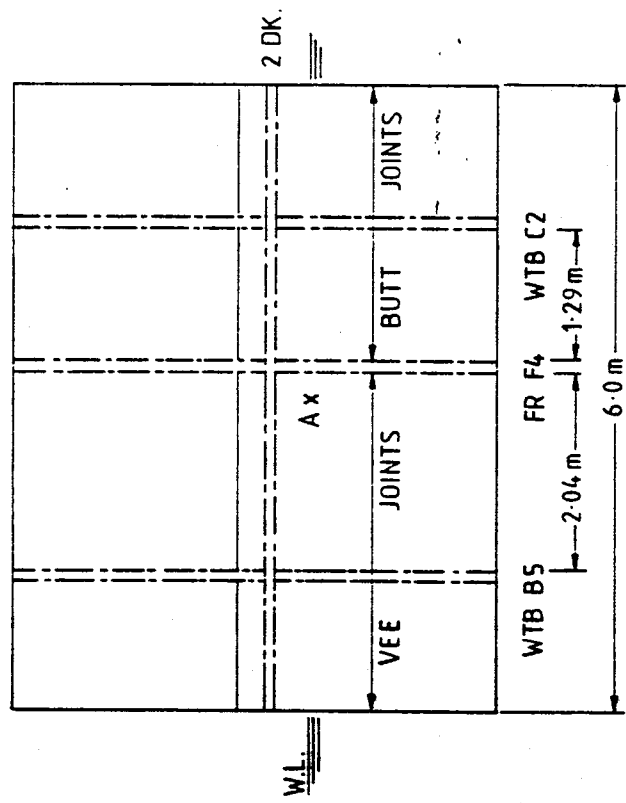
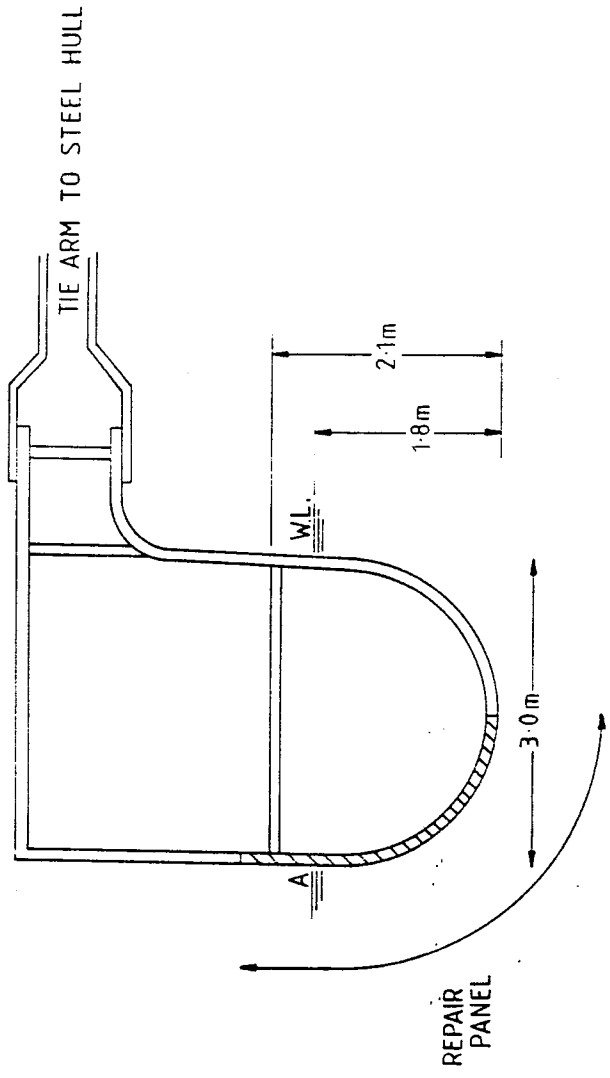
fig1 G.R.P. Test Rig (Showing Repair Panel For 1985 Trial)

7. Phase 1 took place in 1985 and successfully validated the proposed shipboard instrumentation. This was done by mounting the instruments on the full scale test section, which had been refurbished for this trial, and then extensively shock testing the rig. This test also provided further information on the shock performance of the hull materials, construction details, and also validated proposed hull repair techniques.
