Technical Meeting — 1 March 2023

Philip Baldwin, Independent Contractor to Defence, Maritime Sustainment Division, gave a presentation on *Remediation of the LHD Propulsion Issues*, to a joint meeting with the IMarEST in the Henry Carmichael Theatre, Sydney Mechanics School of Arts in the Sydney CBD, and streamed live on 1 March. The presentation was attended by 20 with an additional 29 online.

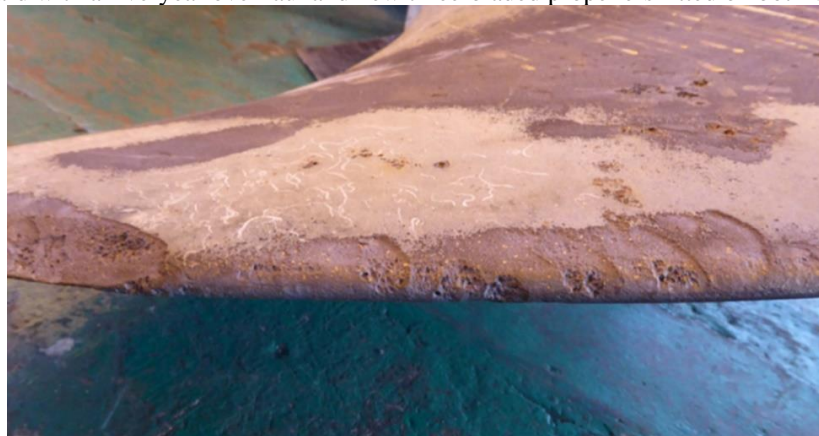
- Corrosion of the propellers: first the nuts holding the propeller blades onto the boss corroded. These were replaced with duplex stainless steel nuts, but then the propeller blades corroded!
- Excessive leakage of water and oil into the pod bilges.
- Cavitation erosion of the propeller blades.
- Complaints from ship's staff about high vibration levels: A notation of CEPAC2 (for Crew and Embarked Personnel Accommodation Comfort 2) had been awarded to the vessels by Lloyd's Register. However, as-built CEPAC2 measurements turned out to be non-compliant with LR rule requirements. High vibration levels were attributed to cavitation, consistent with blade erosion.

HMAS *Adelaide* propeller blade with tip-vortex cavitation and corrosion material removed at May 2017 dry docking after 19 months in service
(Photo courtesy Defence)

Consequently, in April 2017 the TaRP was formed to investigate and remediate LHD material shortcomings. Both LHDs were docked, HMAS *Addelaide* in May/June and HMAS *Canberra* in September/October. Pods were returned to standard with a five-year overhaul and new three-bladed propellers fitted on both vessels.

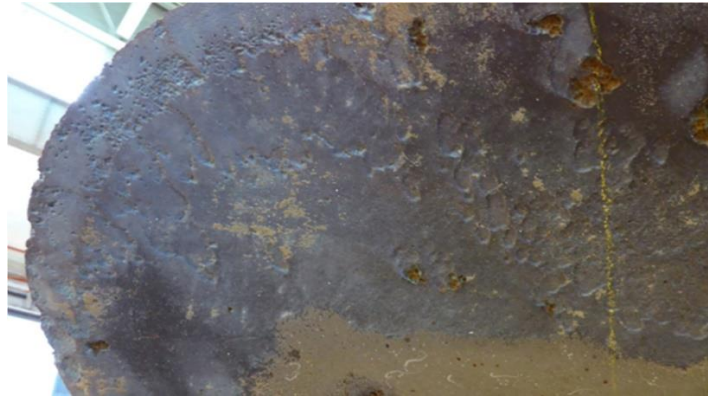
- Corrosion Investigation: This was led by NTB and DST and identified a number of issues which were leading to galvanic corrosion of the propeller blades including the impressed-current cathodic protection (ICCP) not performing to the design intent.
- Vibration Investigation: LR's Technical Investigation Department (TID) were contracted in July 2016 to undertake whole-of-ship structural vibration and CEPAC2 surveys, but no ship time was allocated.

HMAS *Adelaide* propeller blade showing corrosion under stable sheet cavitation at May 2017 dry docking after 19 months in service
(Photo courtesy Defence)

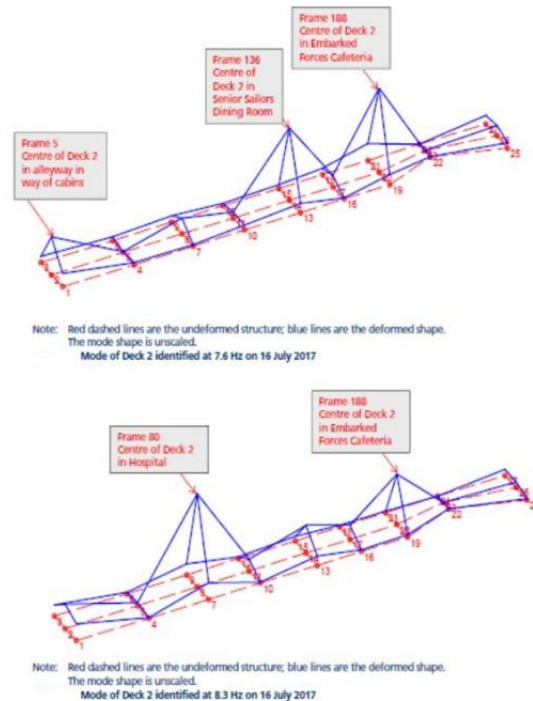
- On 2 Deck, modes were identified at 7.6 Hz and 8.3 Hz corresponding to propeller first blade rates of 152 and 166 rpm respectively. The solution would require structural modifications to 2 Deck and reducing the propeller pressures exciting the hull.
- On the Aft Mast, local modes were identified at 5.9 Hz and 6.8 Hz, with vibration amplitudes exceeding MIL-STD-167-1 for electronic equipment. The solution would require local structural modifications to the mast and reducing the propeller pressures exciting the hull.

Results of empirical modal analysis on 2 Deck
(Diagram by LR TID courtesy Defence)

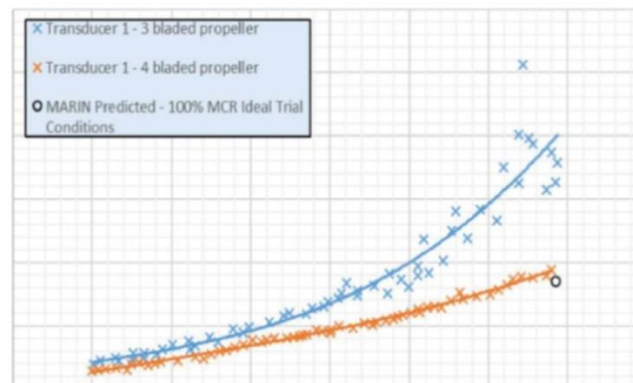
- No sheet or root cavitation was observed during run ups or run downs on the forward propeller. Tip vortex cavitation was observed from 130 to maximum shaft RPM, but assessed as non-erosive.
- No sheet cavitation was observed on aft blades as they passed top-dead-centre. Tip vortex cavitation was present from 62 RPM and boss vortex cavitation from 74 RPM, but assessed as non-erosive.
- Cloudy dispersed cavitation was observed on the suction side root of the aft propeller from 95% of maximum RPM.
- The maximum pressure-pulse single-amplitudes for the forward and aft propellers were within the design acceptance levels.
- Pressure pulse levels for the four-bladed propellers reduced by 52% and 29% for the forward and aft propellers respectively, compared to the original three-bladed propellers.

Forward propeller pressure pulses at first-order blade rate
(Graph by LR TID, courtesy Defence)

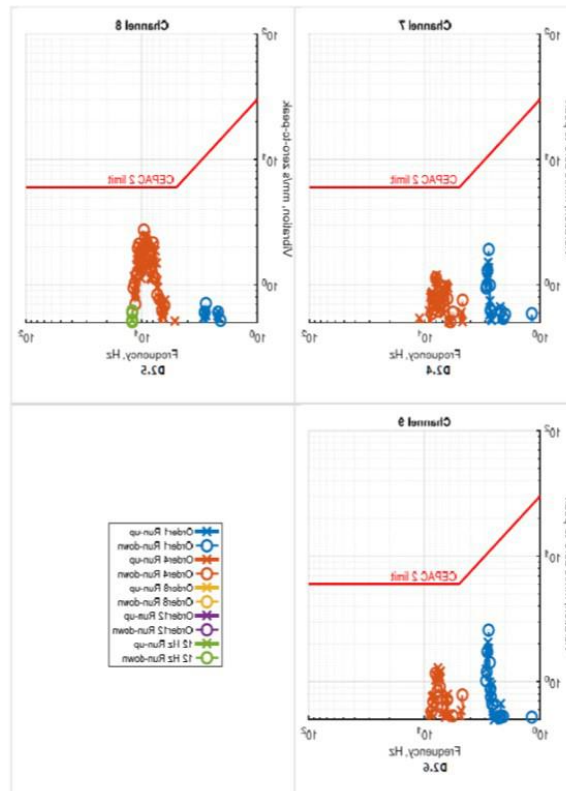
Frame 80 PCRF (hospital) vibration levels during run up/run down
(Graphs by LR TID, courtesy Defence)

- Hull plating above the propellers: 60–70%
- Deck 5, main switchboards N1 41% and N2 62%
- Deck 2, Frame 5: 59% (previously above the applicable limit)
- Deck 2, Frame 80 in way of the PCRf (hospital): 82% (previously above the applicable limit)
- Deck 2, Frame 138 in way of the Senior Sailors' and Officers' Dining Rooms: 50%
- Deck 2, Frame 189 in way of the Embarked Forces Cafeteria: 68% (previously above the applicable limit)
- Deck 2, Frame 272: 51%
- Level 01, Frame 279: 62%
- Level 04, Commanding Officer's Sea Cabin: 59% (previously above the applicable limit)
- Level 05, Navigation Bridge: 61% (previously above the applicable limit)
- Level 05, Flight Control Room: 59% (previously above the applicable limit)
- Central Mast: 43%
