ROYAL INSTITUTION OF NAVAL ARCHITECTS
AUSTRALIA DIVISION

RENEWAL OF THE PLATING IN WAY OF THE
ENGINE ROOM CLOSURE PLATE OF HMAS OTWAY DURING
THE SUBMARINES THIRD REFIT

G. W. SLOAN BE (NAV ARCH) UNSW.

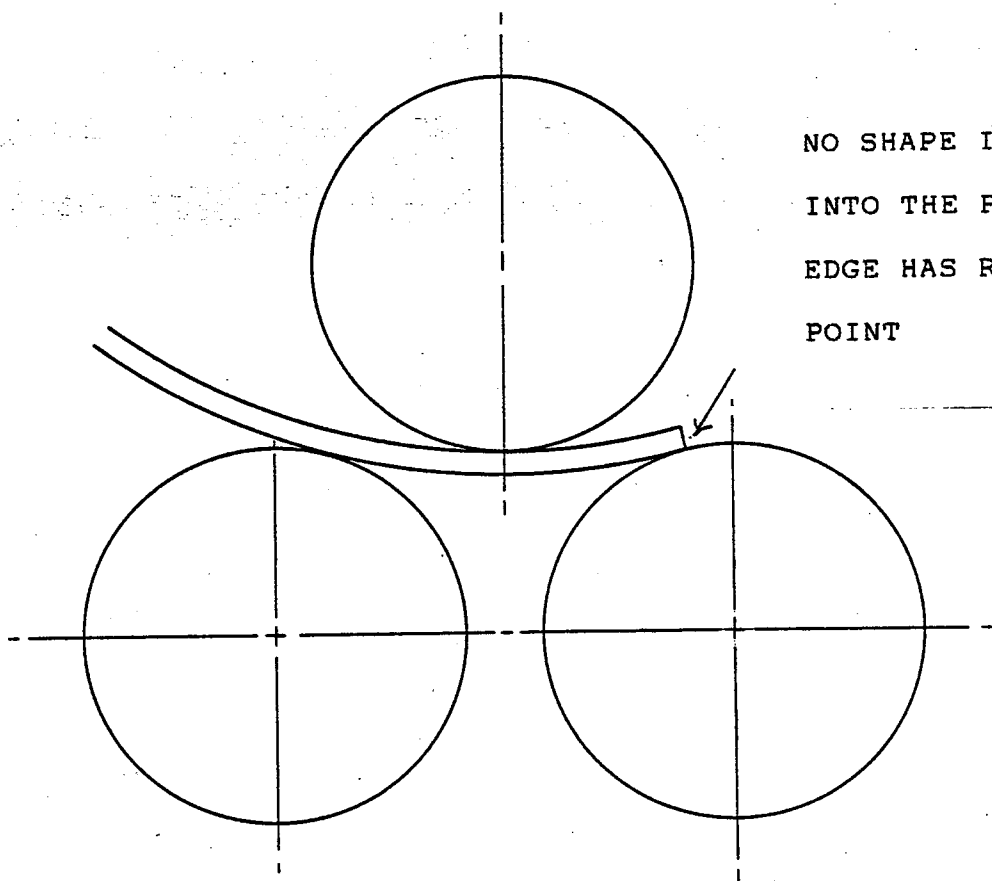
SKETCH 3 OPERATION OF PLATE ROLLS
SHOWING HOW FLATS OCCURED IN PLATE

NO SHAPE IS ROLLED
INTO THE PLATE ONCE
EDGE HAS REACHED THIS
POINT

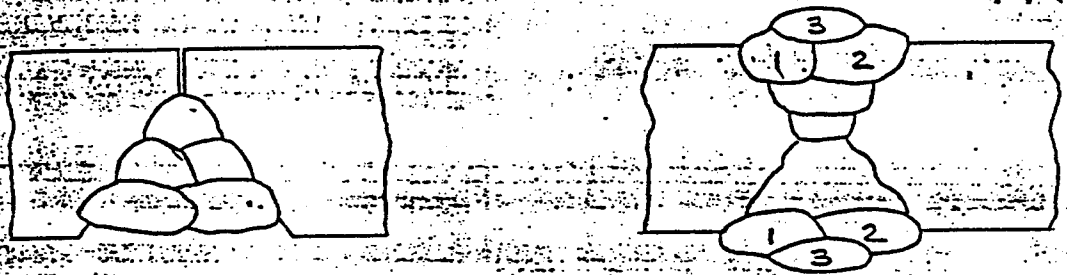
SKETCH 15 DETAILS OF NORMAL WELD PREPARATION
USED ON PRESSURE HULL PLATE

CAPPING TO BE DEPOSITED WITH CENTRE RUN LAST (TEMPER RUN)

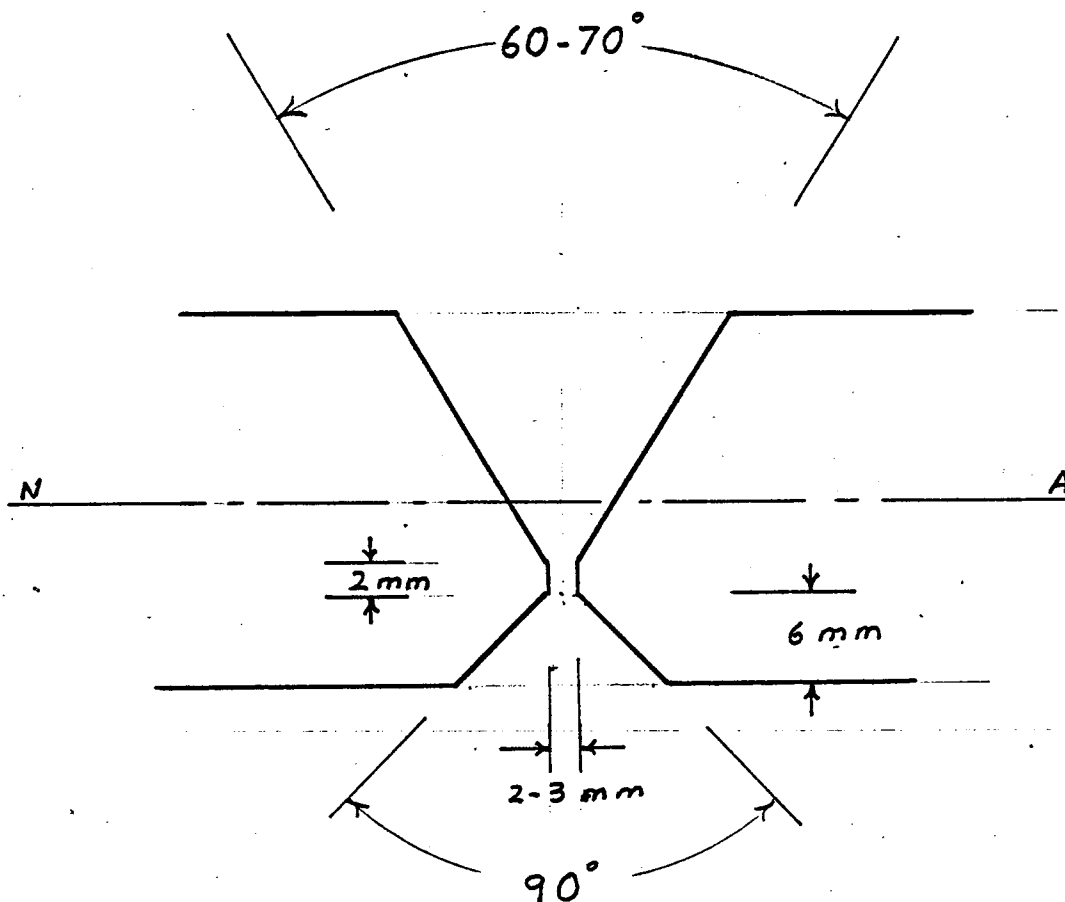
SKETCH 16 DETAILS OF WELD PREPARATION FOR USE OF CERAMIC BACKING STRIP. THE CERAMIC TILE WHICH IS MOUNTED ON AN ADHESIVE BACKING STRIP IS FITTED INTO THE BOTTOM 90° BEVEL AND THE ADHESIVE STRIP IS ADHERED TO THE SURFACE OF THE PLATE HOLDING THE TILE IN THE CORRECT POSITION

1. It is more tolerant to poor fit up as a root gap is required .
2. No backgouging is required only light grinding, slag tends to fuse to the ceramic tile.
3. Less weld metal required as no backgouge and weld profile is not as large.
4. Better distortion control.
5. Faster deposition of first run as in general a 5mm rod is used. With the normal weld preparation you are committed to a 4mm rod to get good penetration.
6. Reduced risk of cracking of the root run as more metal initially deposited hence a stronger root.
