WOLFSON UNIT

Freeboard Guidance.

What does it mean?

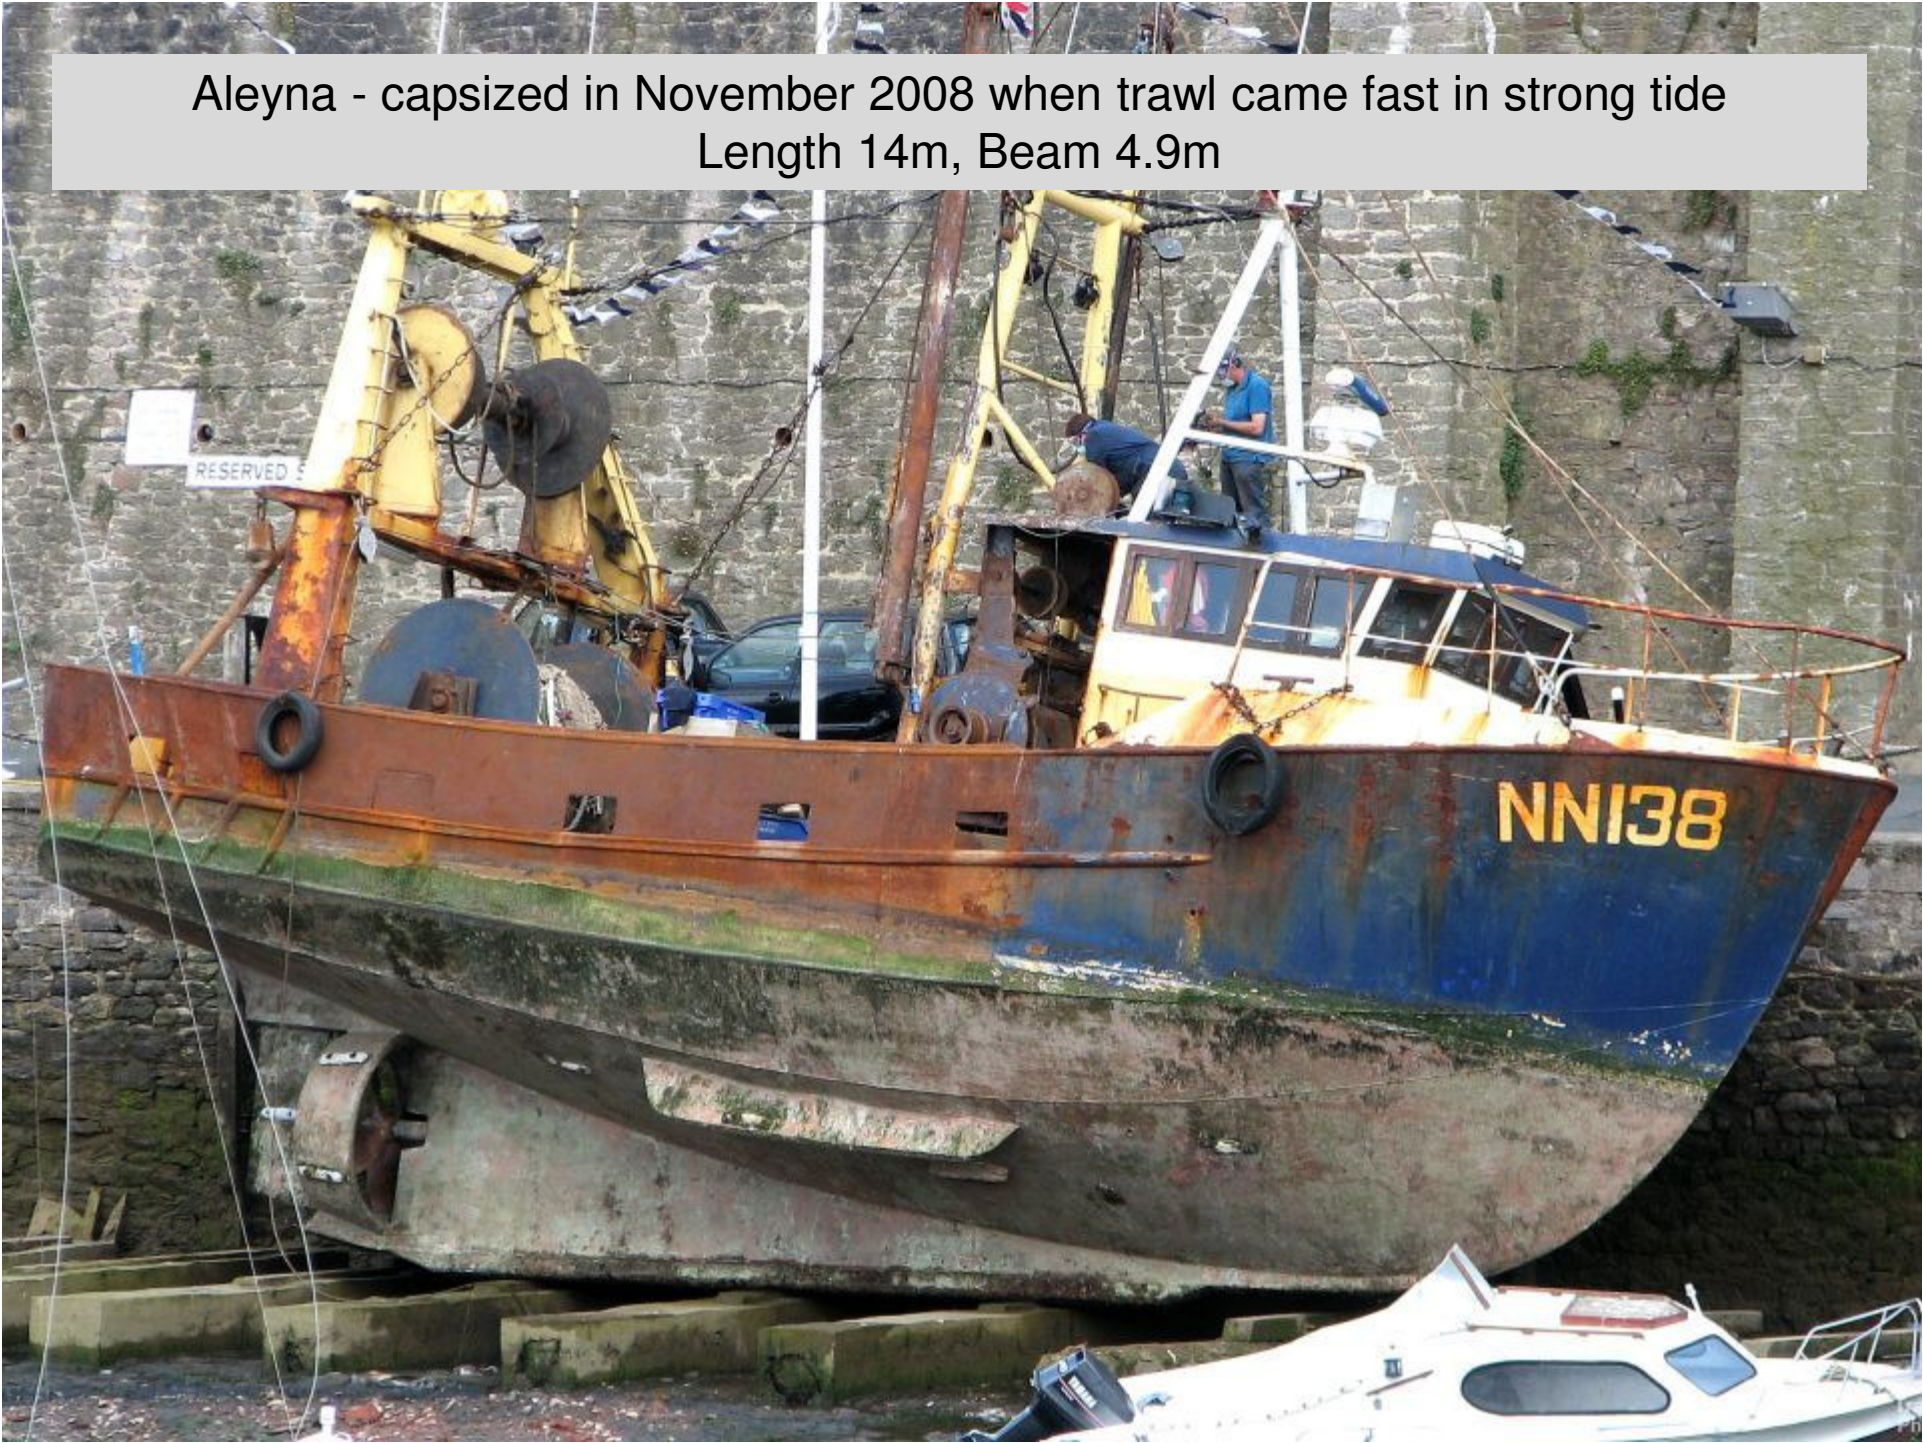
Aleyna - capsized in November 2008 when trawl came fast in strong tide
Length 14m, Beam 4.9m

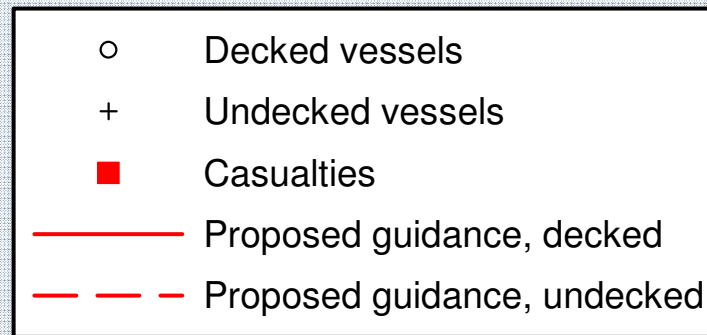
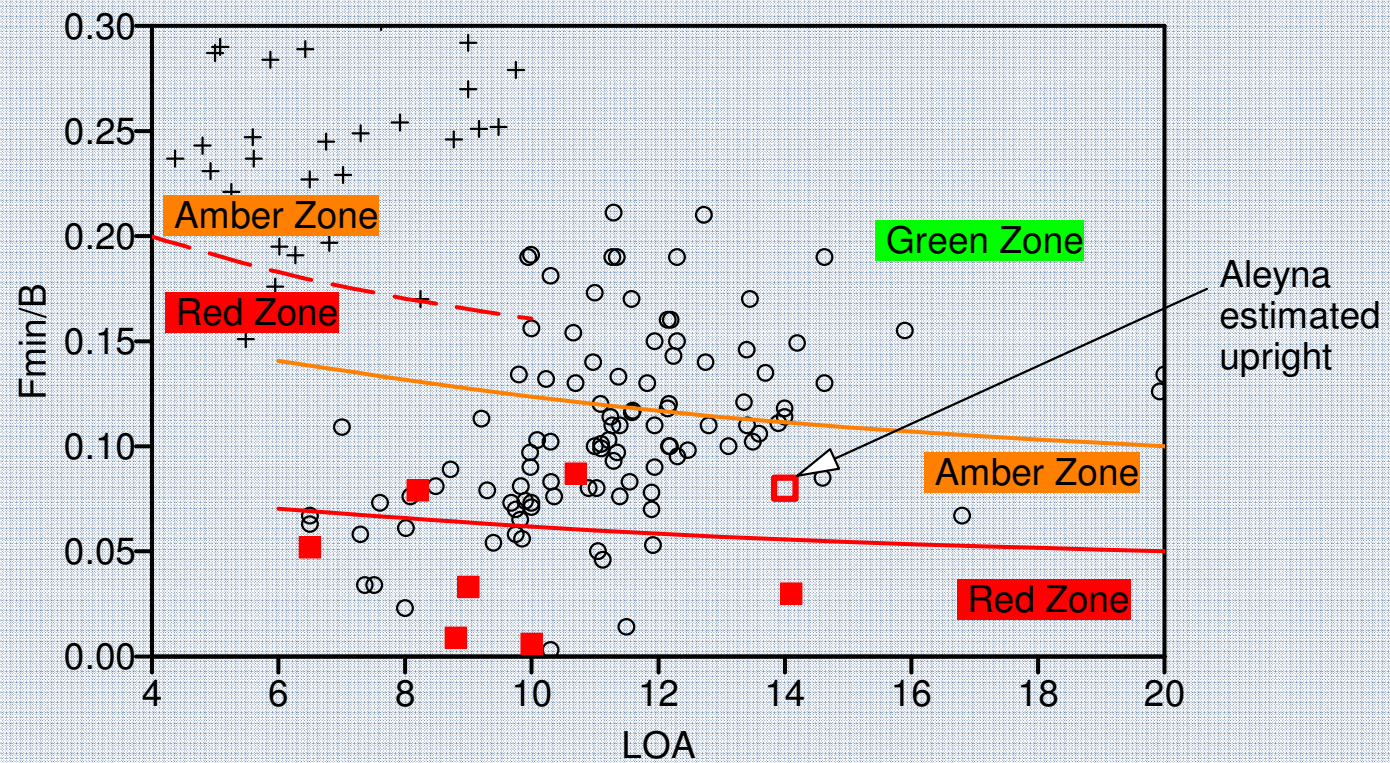
Aleyna

Very low freeboard - Amber safety zone in normal operation when upright

No margin for lifting - Any significant lift reduced freeboard to Red danger zone

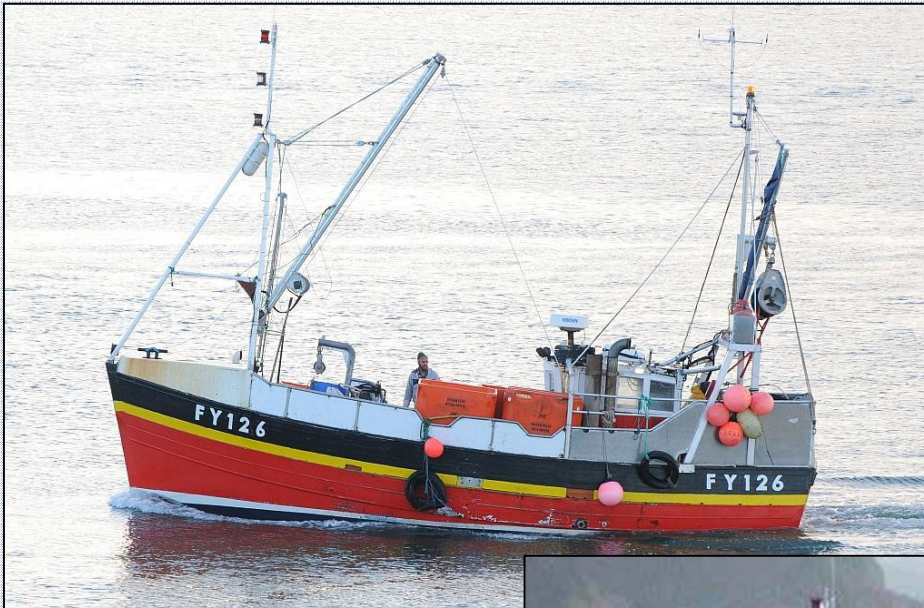
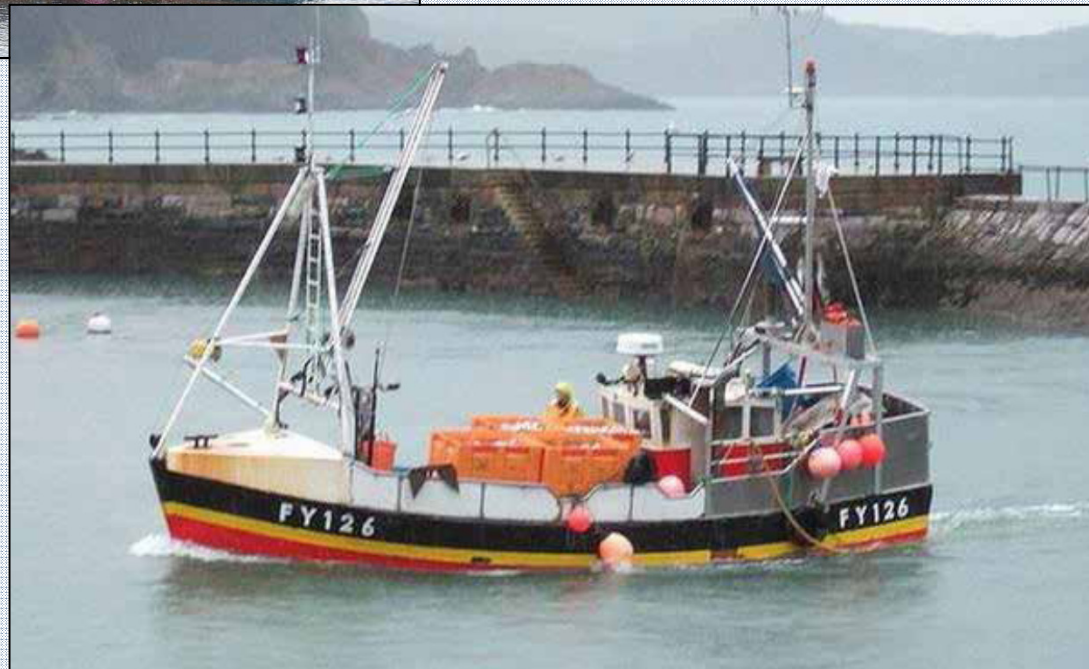
Heather Anne -
Capsized in December
2011 while overloaded

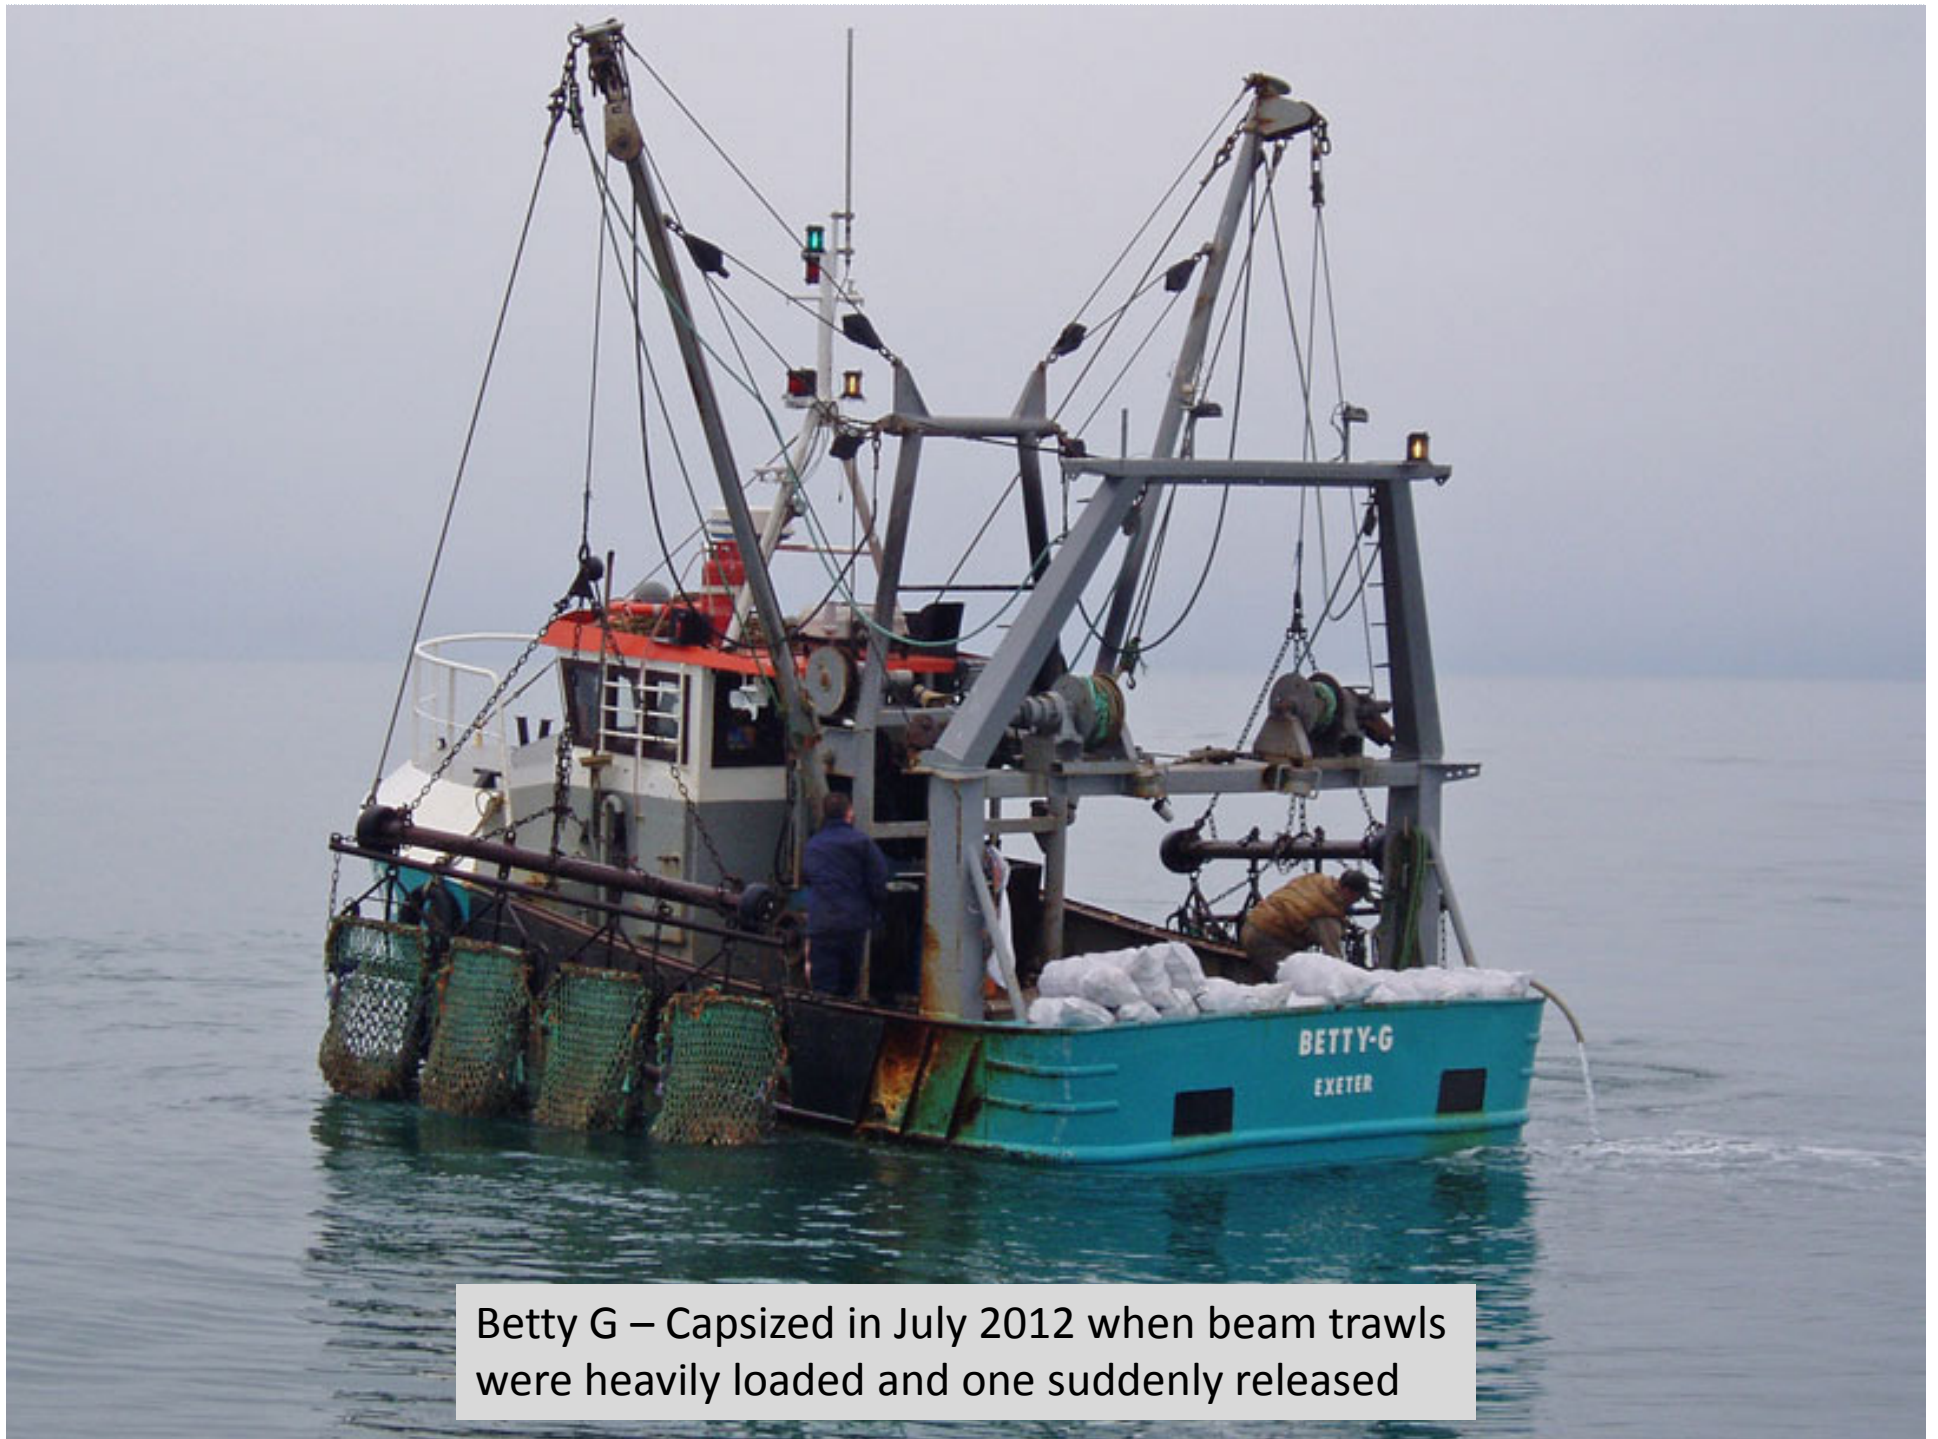
Betty G – Capsized in July 2012 when beam trawls were heavily loaded and one suddenly released

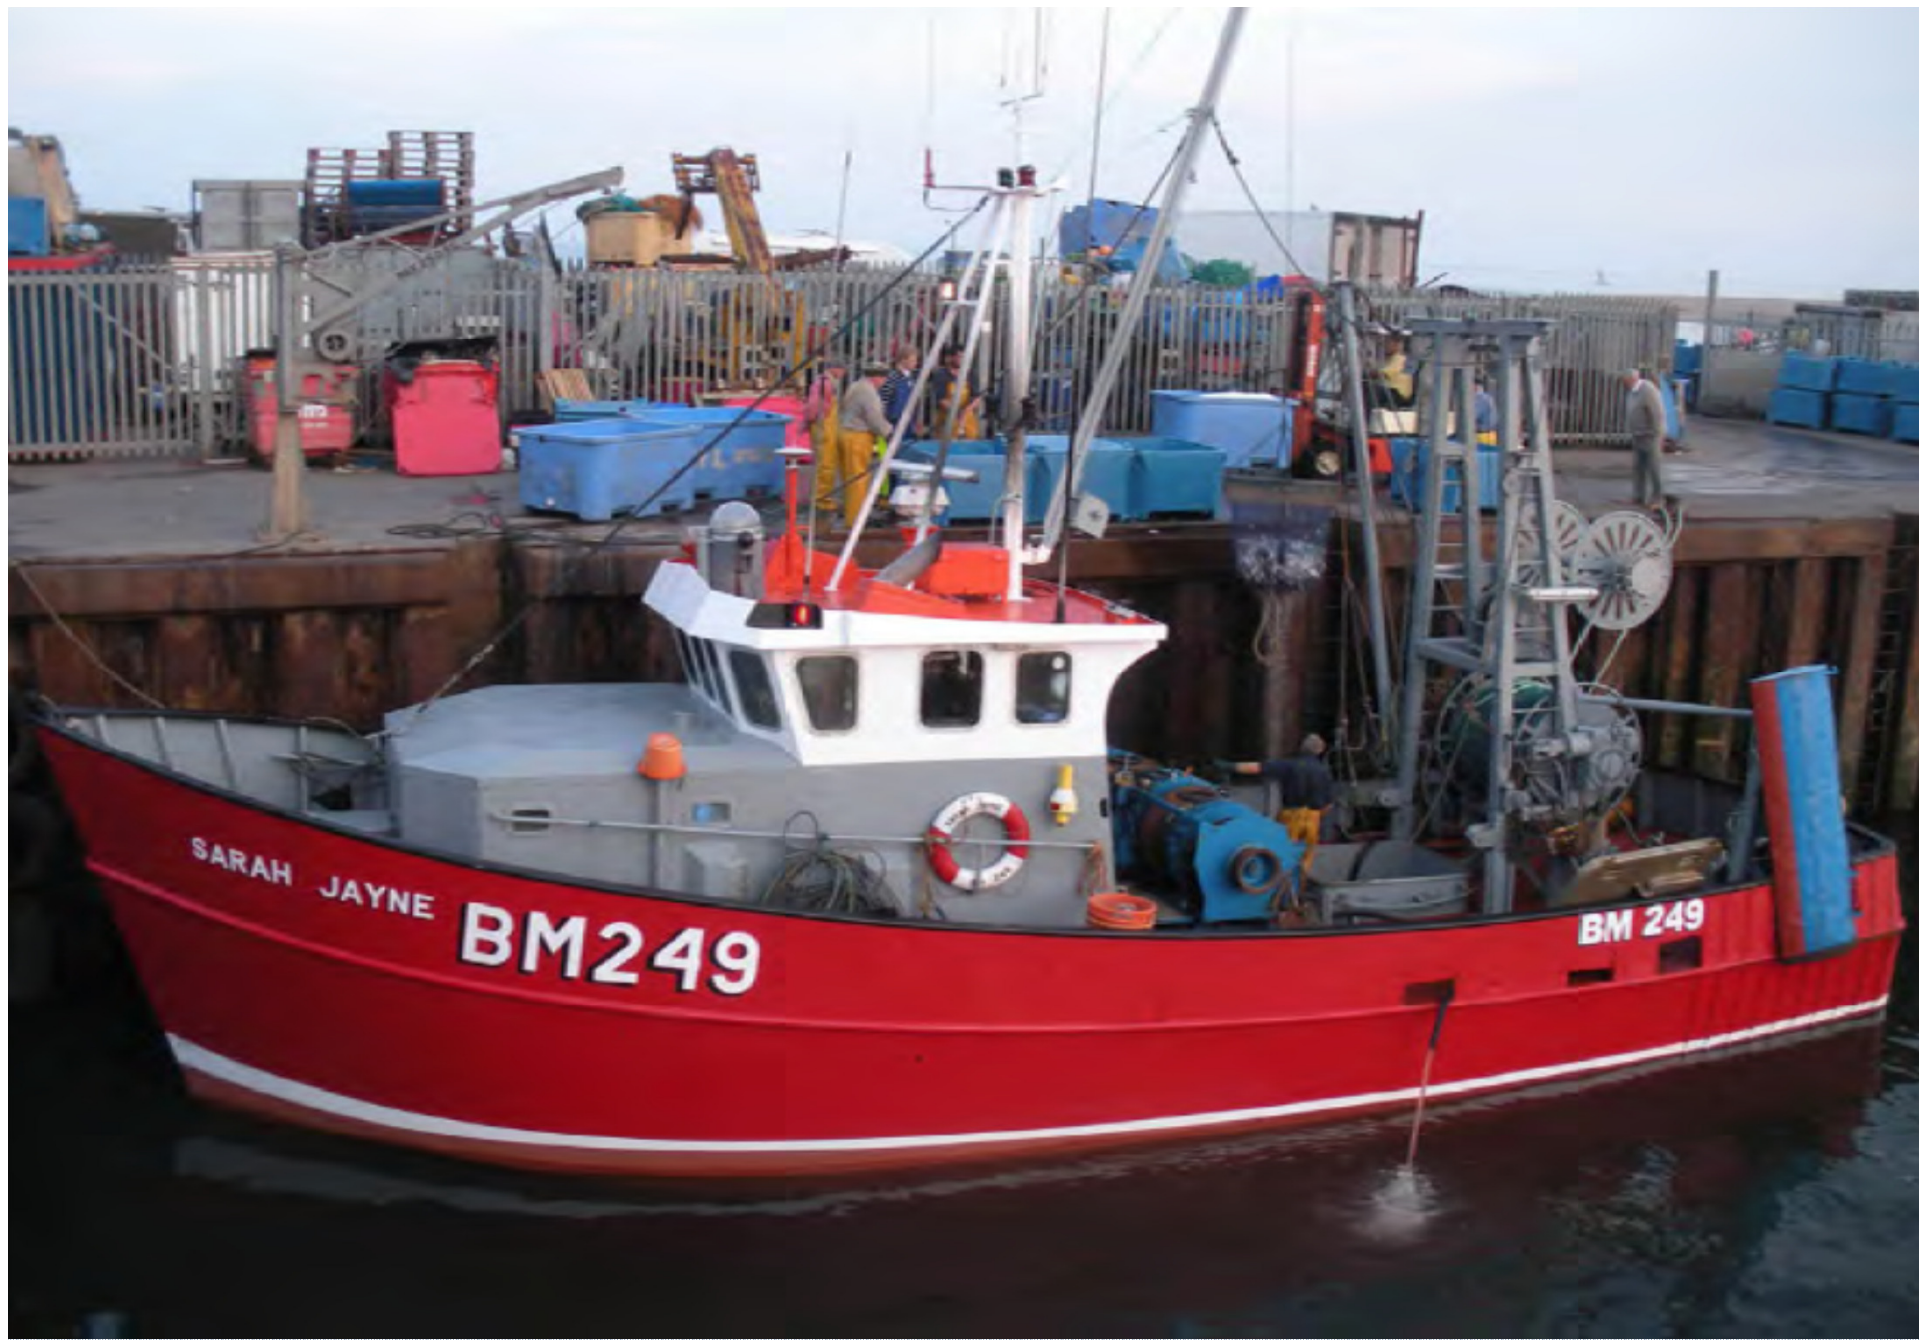
Sarah Jayne – Capsized in September 2012 when overloaded and lifting

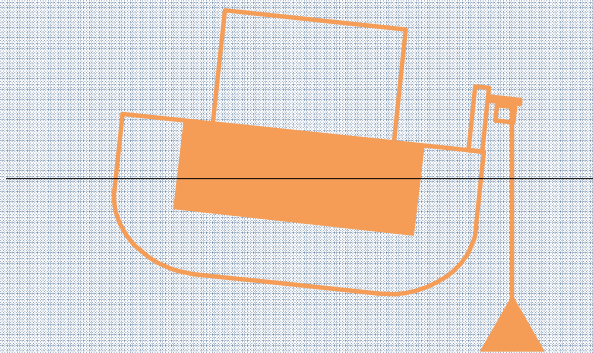
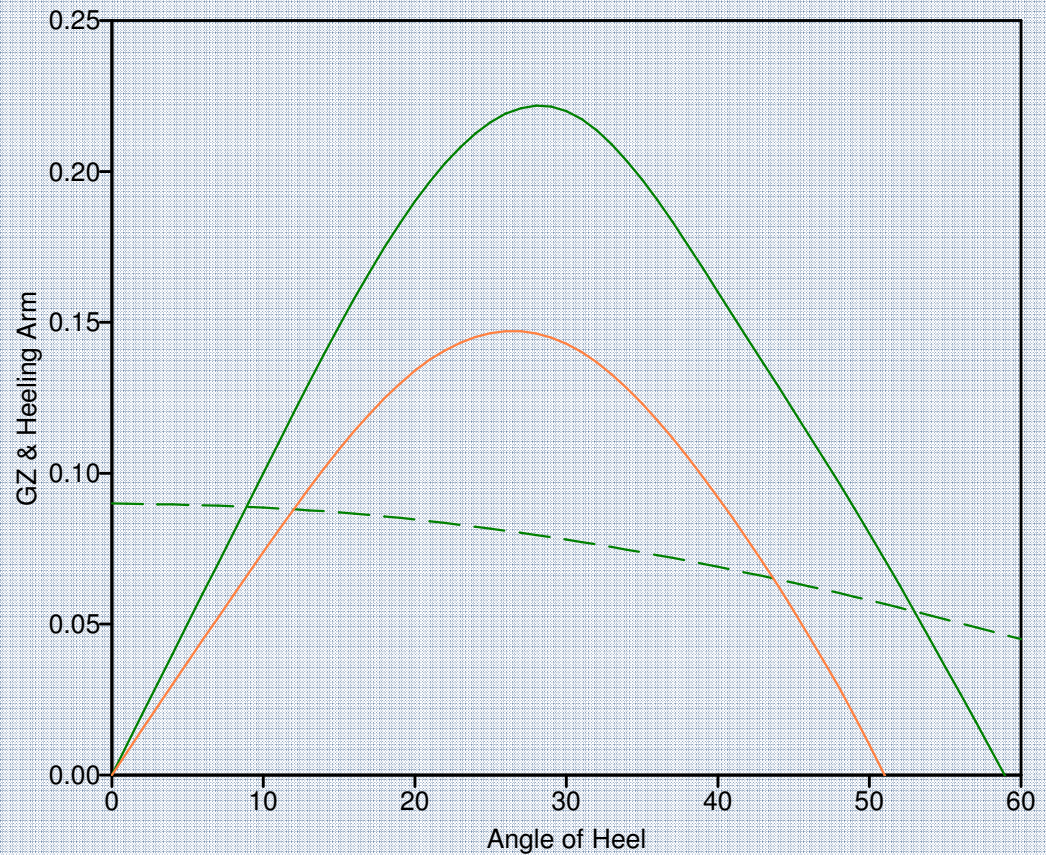
Vessel overloaded, lifting gear

GM:	good
Freeboard:	reduced
Range:	31 degrees
RMmax:	0.06

Freeboard mark at waterline

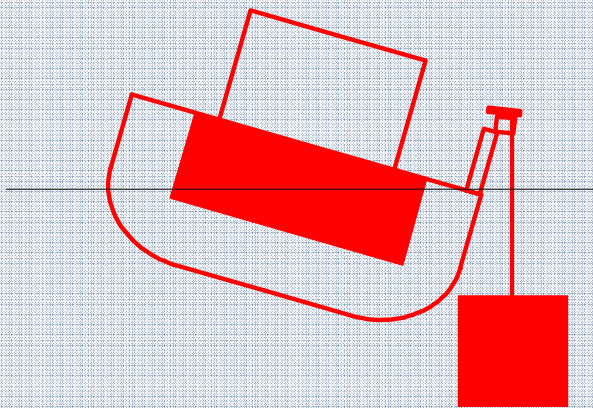
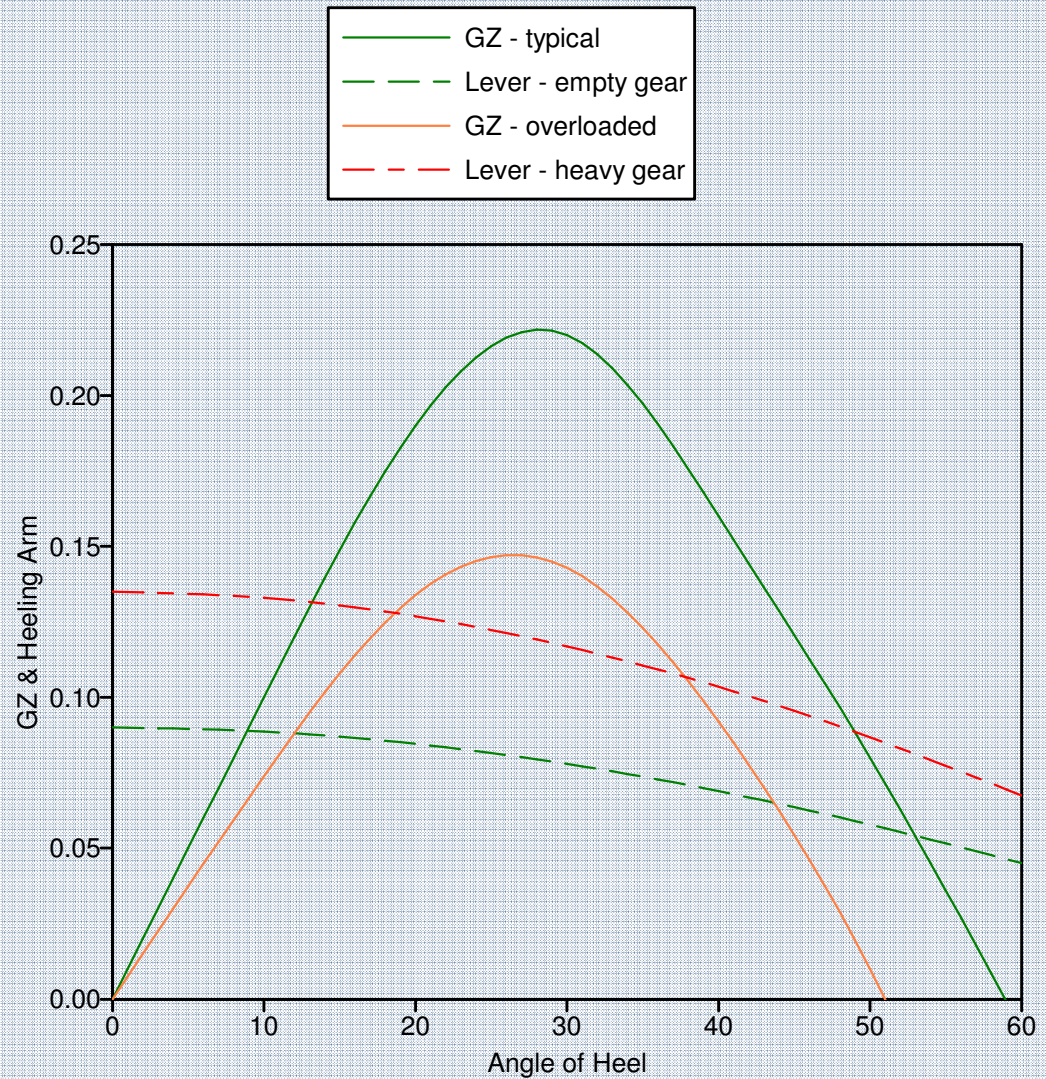
Vessel overloaded & heavy lift

GM:	adequate
Freeboard:	none
Range:	19 degrees
RMmax:	0.027

Freeboard mark submerged
