Drew Shannon, Manager East Coast, London Offshore Consultants, gave a presentation on *Salvage of Containership Rena off Tauranga in New Zealand* to a joint meeting with the IMarEST attended by 30 on 5th October in the Harricks Auditorium at Engineers Australia, Chatswood.

Drew began his presentation by saying that *Rena* was a 236 m, 3351 TEU Panamax containership, built in 1990 Howaldtswerke-Deutsche Werft AG in Kiel, Germany, and owned by the Greek shipping company Costamare Inc. through one of its subsidiaries, Diana Shipping Co.

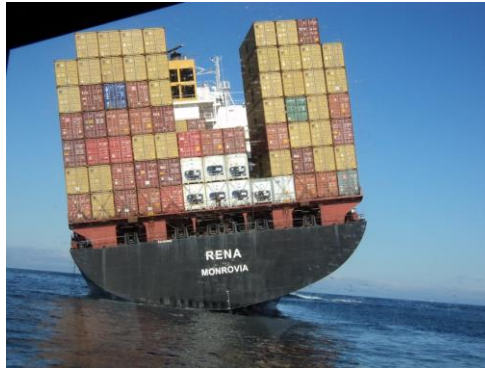
Aft container stack on *Rena*
(Photo courtesy Drew Shannon)

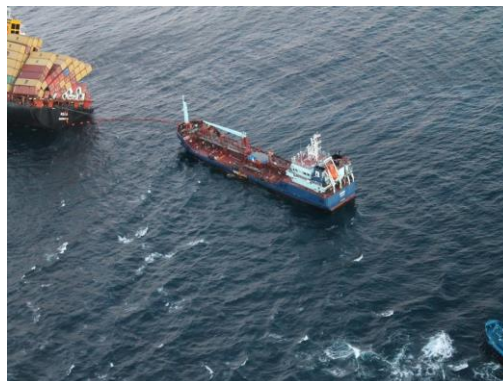
Awanuia and *Waka Kane* removing oil from *Rena*
(Photo courtesy Drew Shannon)

Svitzer were appointed as salvors on 6 October (the day after the grounding) and they commenced mitigation works on board. The Swedish Club, insurers of *Rena*, appointed a Special Casualty representative (SCR) who arrived on site on 6 October. Svitzer's naval architect arrived from The Netherlands to begin essential assessments, and Svitzer chartered the bunker barge *Awanuia* and tug *Waka Kume* from Auckland and they arrived on site on 9 October, with oil removal equipment arriving on the same day. *Awanuia* was connected to the stern of *Rena* and held off by the tug, and the first stage of oil removal was underway, direct hot dipping into tanks.

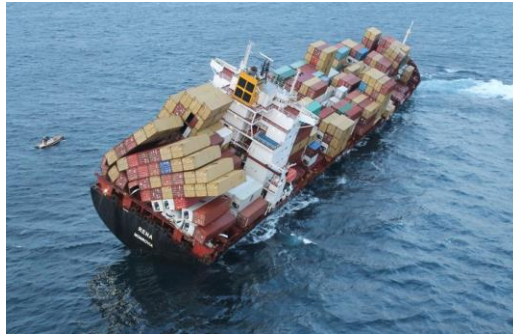
The salvage team managed to re-board the vessel on 13 October, but the 23° list made movement around the vessel precarious. Serious structural damage was noted — the vessel was effectively broken into two sections in way of Frames 191P–181S; i.e. at No. 3 hatch.

Amazingly, most of the twist locks on the container stacks held, despite the 23° list!

Container stacks on *Rena* on 13 October
(Photo courtesy Drew Shannon)

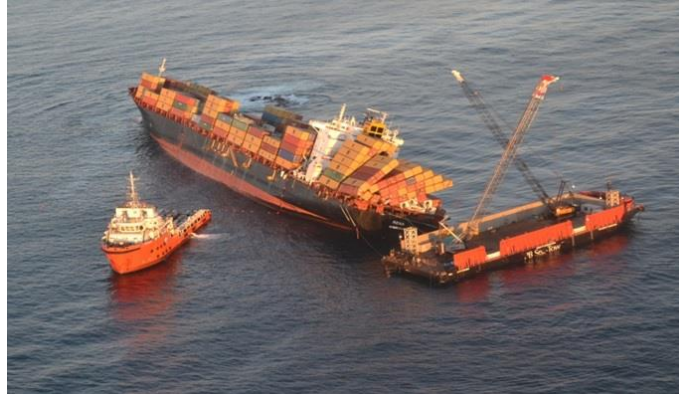
Rena with crane barge *ST60* ready for cargo discharge
(Photo courtesy Drew Shannon)

Heavy crane barge *ST60* had arrived from Singapore and, on 15 November, was positioned at the stern of *Rena* for cargo-discharge operations. Containers were recovered to *ST60* and then transhipped to *Go Canopus* for discharge ashore in Tauranga. The lifeboats had to come off too, and there were questions about import tax! Eventually the lifeboats were sold to a local polytechnic for \$1.

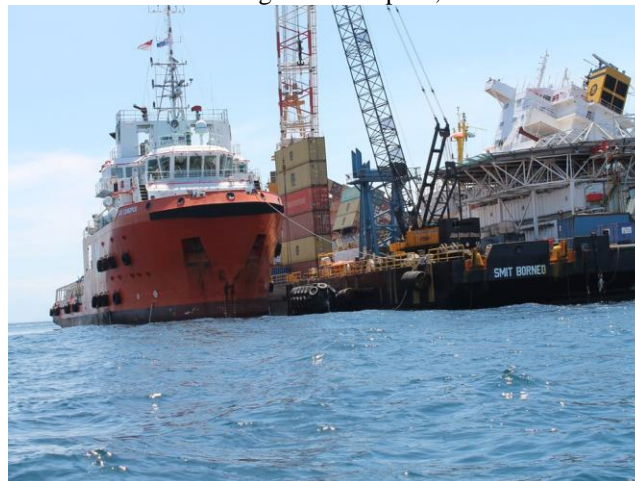
Smit Borneo unloading a stack of six containers
(Photo courtesy Drew Shannon)

Smit and Svitzer agreed terms on a joint venture, and *Smit Borneo*, having a larger crane and larger container capacity, arrived on 11 December and replaced *ST 60*. The speed of discharge improved significantly, as *Smit Borneo*'s crane could reach either side from port or starboard, and was not held up by weather as was *ST60* whose crane could not reach both sides. Containers could also be lifted off in stacks of six at a time with the bigger crane. However, *Smit Borneo* did not have great deck space, and so offloaded containers to *ST60*.

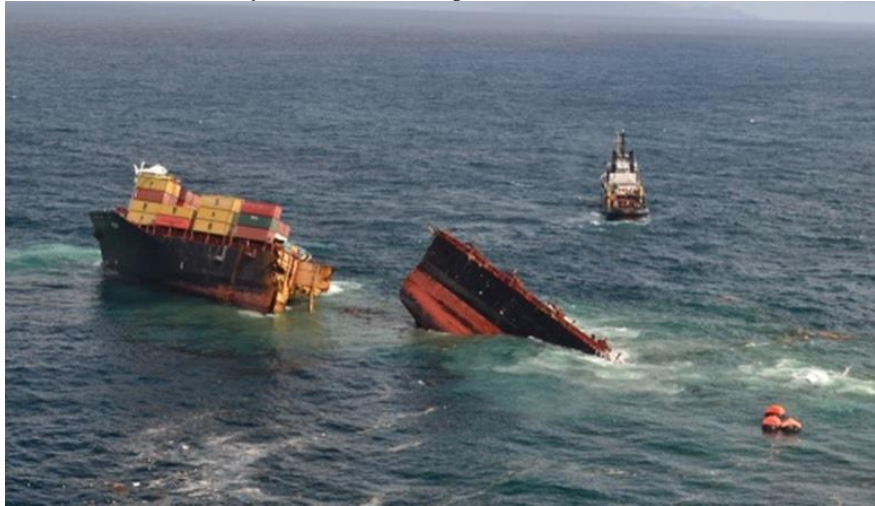
The new year (20120) brought a protracted period of unsettled weather, and each weather event had a detrimental effect on the wreck. On 7 January they had 11 m seas (recorded on the ocean data buoy) due to a cyclone which had passed by to the north and, by that time, no-one was living on board *Rena* any more; they had moved onto *Smit Borneo*. On 8 January there was total separation of the aft section from the forward section.

Rena on 10 January 2011
(Photo courtesy Drew Shannon)
