Project Silent
ANZAC

Preliminary
Analysis of
Imagery Data

February 2015

Preliminary Analysis of Imagery Data arising from the 2014 Internal Investigation of HMAS AE2

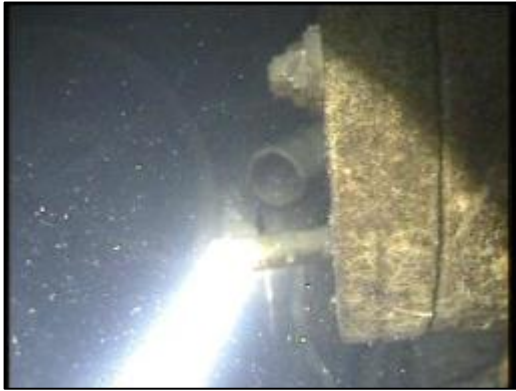
Figure 3 - An Image recorded from the MK 1 Drop Camera used during MAA07, showing the Conning Tower Telegraph at Right.

The experience of MAA07 (3) had been that it was advisable to separate the source of illumination as far as possible from the camera, as co-locating camera and light source causes bad "flaring" due to specular reflection from suspended matter in the water, as can be seen in Figure 3. Hence it was decided to build luminance-controllable, LED lighting modules that would be mounted approximately 450 mm above and below the centreline of the camera. Providing two lighting modules had the twin benefits of:

(Note the flare on the image is a result of having the light source virtually co-located with the camera.)

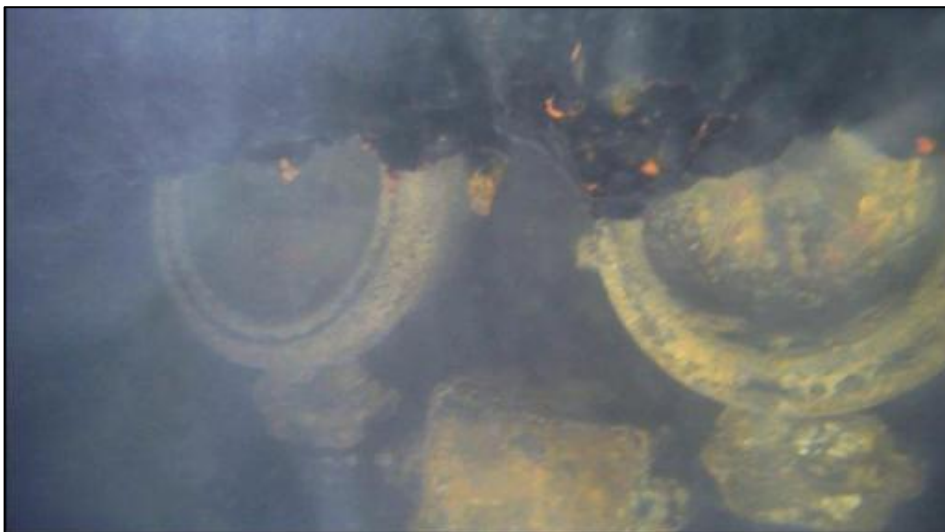
Figure 22 - The first view of Speed and Depth Gauges as the Drop Cam is lowered into the Control Room

On the second attempt the system was successfully installed into the boat, with the Sonde being lowered to the level of the battery tank. The lighting modules proved very effective in providing uniform, soft light for the interior; hence excellent video imagery was able to be recorded. Figure 22 shows the first view of the control room's starboard side as the camera cleared one of the suspended, overhead trunks. The "smoky" appearance of the image is not an artefact. This is a realistic representation of what the water is like near the top of the control room. On this occasion the diver exhausted his time on the bottom so the system was left inside the submarine overnight.

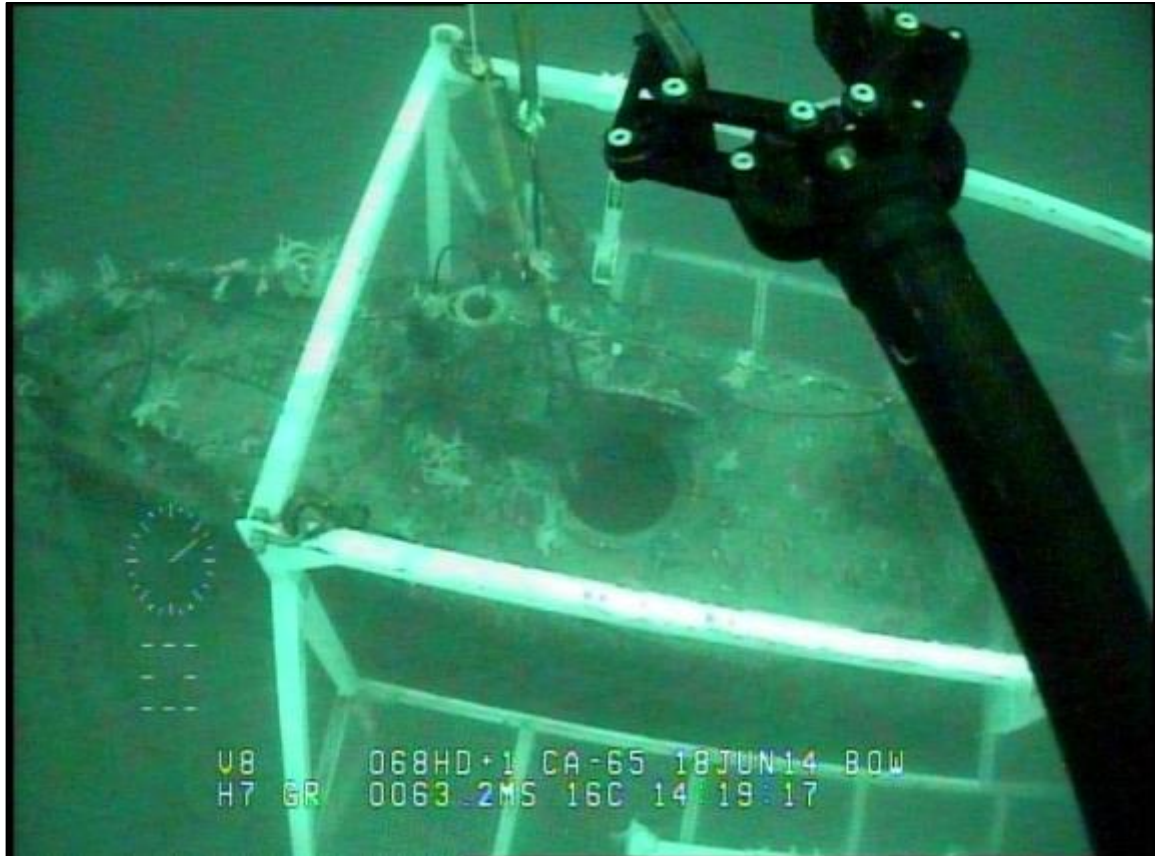
Figure 23 - Showing the Final Orientation of the Opened Upper Hatch

Regardless of whether the Pole Cam was to be deployed or not, the hatch had to be opened to allow insertion of the ROV. The divers configured a long-travel, mechanical screw jack so that its baseplate could rest on the hatch "coaming"⁷ and a modified runner inserted under the hatch lid. This proved very successful in opening the hatch, but as the hatch opened the top of the jack had to shift over to port to follow the rotation of the hatch cover. The result was that, eventually the jack slipped under the copper jumping wire, which links the two periscope standards, and jammed. At this point the hatch was judged to be opened to an angle of approximately 75 degrees, as shown in Figure 23. Considerable time was lost in releasing the jack from the jumping wire and geometric modelling showed there should be sufficient clearance to allow the vLBV to be installed into the submarine, so the hatch was left at that orientation. From a material disturbance point of view, the impact of the hatch opening evolution was that a reasonable amount of concretion was removed from the top of the conning tower in the vicinity of the hatch (varying between about 50-100 mm), one hatch clip had to be cut and the hatch was rotated through approximately 65 degrees.

From both a maritime archaeological perspective and for the sake of the security of the wreck, it was important to restore the upper hatch opening to something approximating the original 10 cm gap. Given that the concretion, which had been effectively securing the hatch prior to the mission, had been dislodged it was not an option to simply close the hatch again. A fiberglass replacement hatch cover had been manufactured prior to the expedition. This cover, shown below, had slots cut into it to simulate the original opening. It was placed over the hatch opening and secured to a "strongback" (the grey object lying on top of the cover), that engaged with the underside of the hatch coaming.

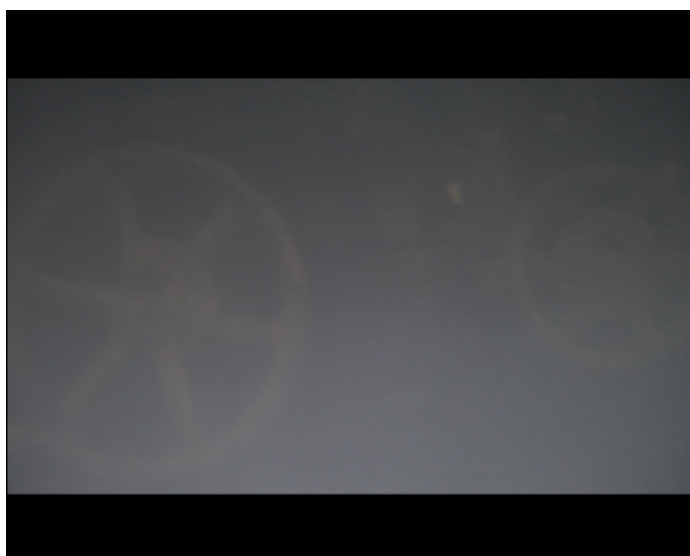
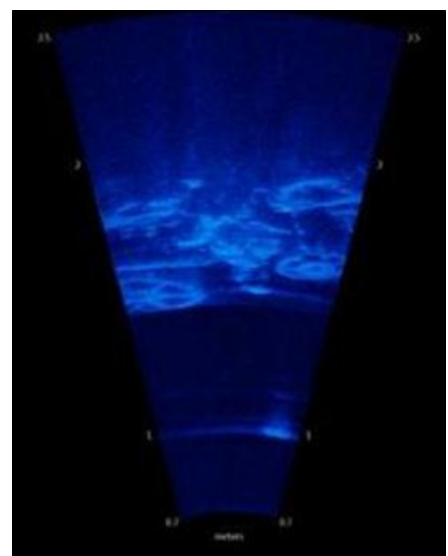
Figure 28 - Video & Sonar Images at the same Position

Figure 28 shows imagery, recorded separately from HD video and the ARIS sonar. The images are looking to starboard, and they both show two of the Kingston valve actuation wheels, plus some of the other ballast control infrastructure. While it may appear to be the case, these images were not recorded simultaneously. The reader is reminded that the sonar is actually a two-dimensional ranging system, not a three-dimensional imaging system. What is actually shown in the sonar images are two-dimensional slices, taken along the direction of the sonar's field of view. In this case, by chance, at one point the system tilted somewhat, so that the sonar was looking slightly upwards, hence the wheels look like wheels. The sonar image which was, in fact, recorded simultaneously with the video image is included as Figure 29. That sonogram takes the form of a cross-sectional view through the Kingston wheels, including presenting a cross-section of the turning handle attached to one of the wheels. Also evident is some of the piping that led to pressure gauges and tapping points. The fidelity of the sonar imagery is sufficient to show that it can be used to facilitate dimensional scaling.

A significant amount of the HD vision and ARIS sonar data were obtained from the SeaBotix vLBV in the conning tower. These data highlighted one of the limitations of the sonar system. For much of the time the distance between the sonar and the sides of the conning tower was closer than the 0.7 metre minimum range which the sonar could resolve, resulting in no displayed signal on the screen. Also the cramped confines and the shape of the conning tower resulted in multiple "bounces" of the sonar signal being received, distorting the displayed return signals. This in no way negates the potential value of utilising sonar data - it simply highlights the fact that acoustic systems have characteristics which must be accommodated, just as video imagery does. As a case in point, the video imagery in Figure 28 is degraded by turbidity of the water, whereas the sonar image is quite unaffected.

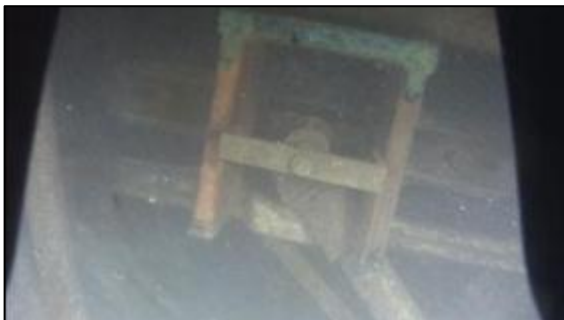
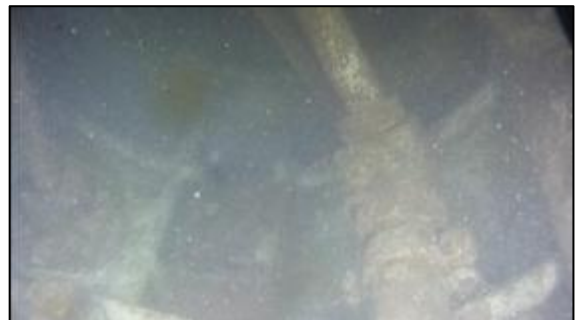
Figure 34 - Showing the Light Pipe that led down to the Control Room

The magnetic compass was mounted high up in the conning tower, where it was clear of ferrous metals. This compass is in good condition, it still has the soft iron spheres on either side of it and the light pipe, leading to the lower helmsman's position in the control room, is still in place.

(Image at **left** is looking upwards towards the compass and image at **right** shows the "elbow" in the pipe mounted at the starboard side of the conning tower.)

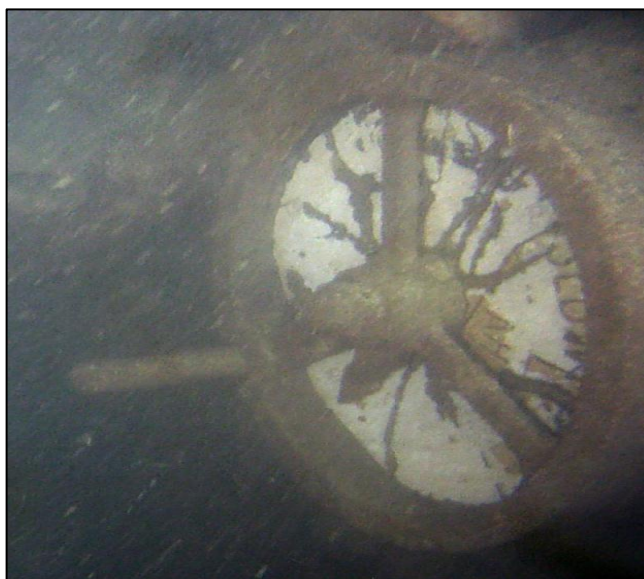
Figure 37 - Starboard Engine Telegraph

The following images give some idea of the large number of items of interest identified in the conning tower. The telegraph is identified in the plans (Drawing 11) as being an indicator for the starboard engine only. This is consistent with what can be seen on the instrument.

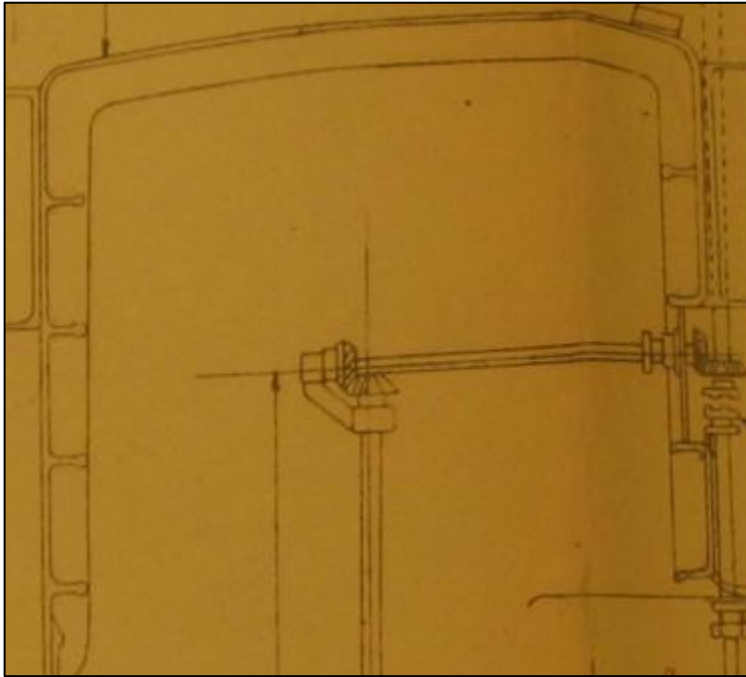
Figure 38 - The Right Angle Drive for the Steering System – Mounted off the Port Side Wall of the Conning Tower

The following example highlights the manner in which MAA14 has expanded upon existing knowledge of AE2's hardware. The only plan which the team has been able to locate, indicating the manner in which the steering actuation was transferred from the two upper steering positions down to the control room, shows a very simple right-angle drive system with exposed gears.

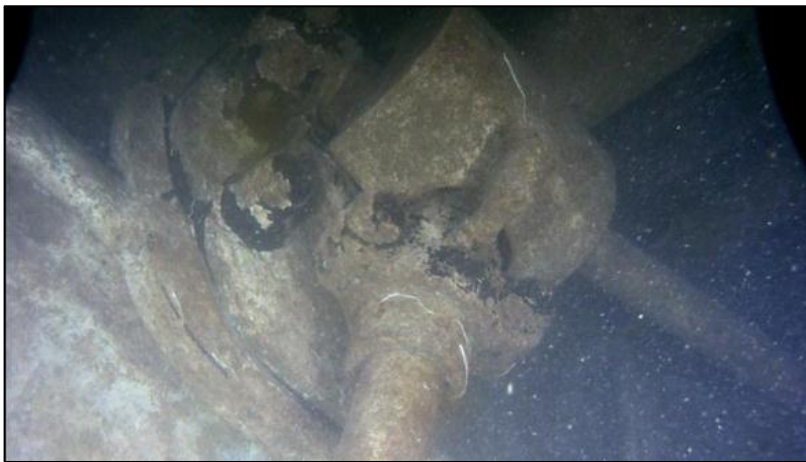
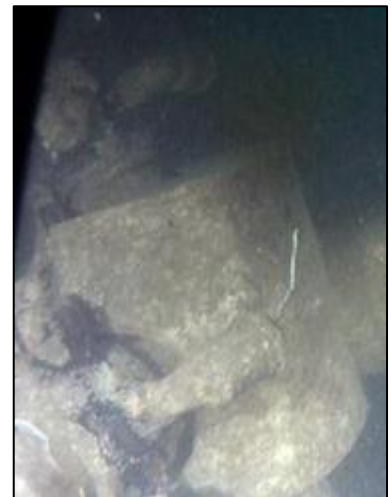
Figure 39 - Two Views of a Right-Angle Drive in the Steering System

The reality was that the gearbox was totally enclosed, but it carried external grease pots which could be filled with grease and then progressively screwed in, enabling the unit to be charged with grease without the need to use a separate grease gun.

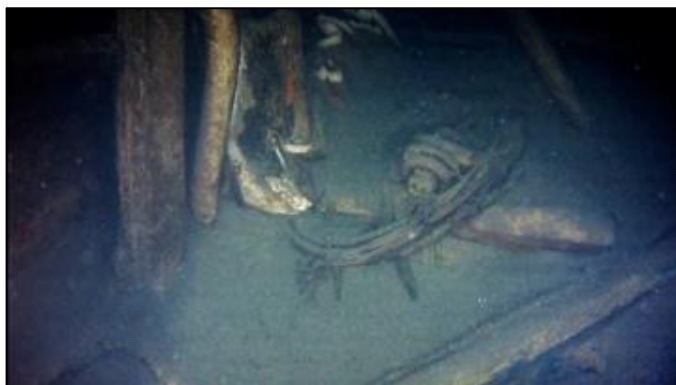
Figure 41 - A Hinged Bracket with Coil of Wire lying on top of it

A number of items were found inside the conning tower which could potentially have been used to make such a temporary radio antenna. A steel plate was found on the floor, with a hinged bracket attached to it. Lying on top of that was a coil of wire and there were at least two poles stowed in the space. While it is not claimed that these were the components of a jury-rigged radio transmission system, further study into their potential uses is certainly warranted.

(There were also at least two poles in the conning tower which were not part of its permanent equipment)

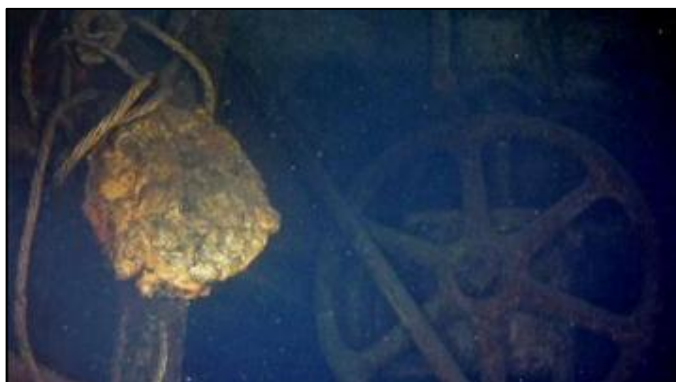
Figure 42 - The Conning Tower Steering Position, with a Second Pole lying immediately Aft of the Steering Wheel

One of the greatest surprises of the first day's operations inside AE2 was that the wheels of the two hydroplane controls and the main helm were found to have corroded away to stubs. This contrasted to virtually every other control wheel inside the boat. The team concluded that, perhaps these three wheels were aluminium. Was this to make them lighter for the crew members to turn? While this had not yet been debated or considered by the corrosion experts, what was apparent was that, while they lasted, these wheels had played the role of sacrificial anodes.
