## Technical Meeting – 2 September 2020

Sean Langman, Managing Director of Noakes Group, gave a presentation on *Ferry Radar Preservation: a Link to a Once-working Harbour* as a webinar hosted by Engineers Australia with Phil Helmore as MC on 2 September. This presentation attracted 70 participants on the evening.

Sean began his presentation by saying that the Rosman ferry *Radar* has been restored to full working order, and will comply with all AMSA's NSCV requirements.

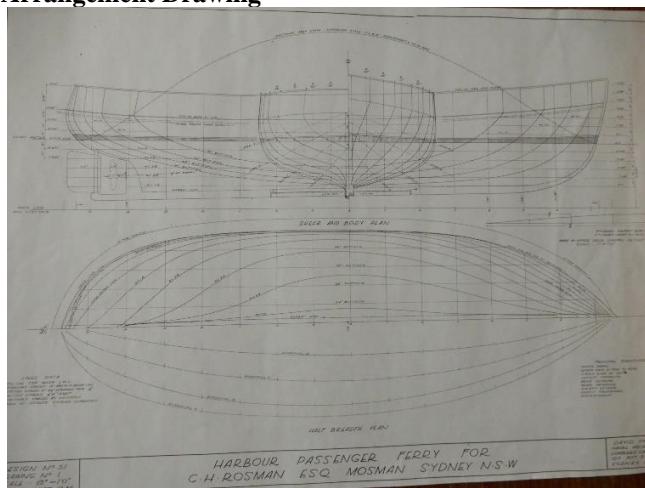
Lines plan of *Radar*  
(Drawing courtesy Noakes Group)

The lines plan and general arrangement drawing of *Radar* are being used today to input data and to analyse her stability. In addition, they are scanning her hull shape to see how much (if anything) has changed and how to incorporate that into the stability data.
