SLF 52/11/2
19 November 2009
Original: ENGLISH

DAMAGE STABILITY REGULATIONS FOR RO-RO PASSENGER SHIPS

Study on the impact of the damage stability requirements of the SOLAS 2009 amendments on ro-ro passenger ships

Submitted by Japan

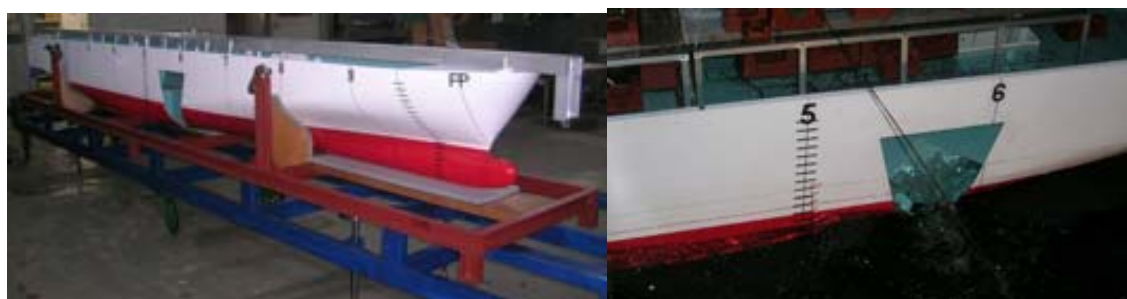
Figure A1 – Photo of model of the RoPax ferry and experiments in beam irregular waves

1 Model tests were conducted with a ro-ro ferry in accordance with “Revised model test method under resolution 14 of the SOLAS conference” (resolution MSC.141(76)). The width of the damage openings and all conditions of experiments are determined based on this guideline.

2 The tests were carried out in the towing tank in National Maritime Research Institute of Japan (NMRI) on July 2009. About 5 m long model, which corresponds to a model scale of 1:40, was used. Damaged compartments and ro-ro spaces are modelled with the correct surface and volume permeability ensuring that floodwater mass and mass distribution are correctly represented. Ventilating and cross-flooding arrangements are constructed to represent the real situation of the subject RoPax ferry.

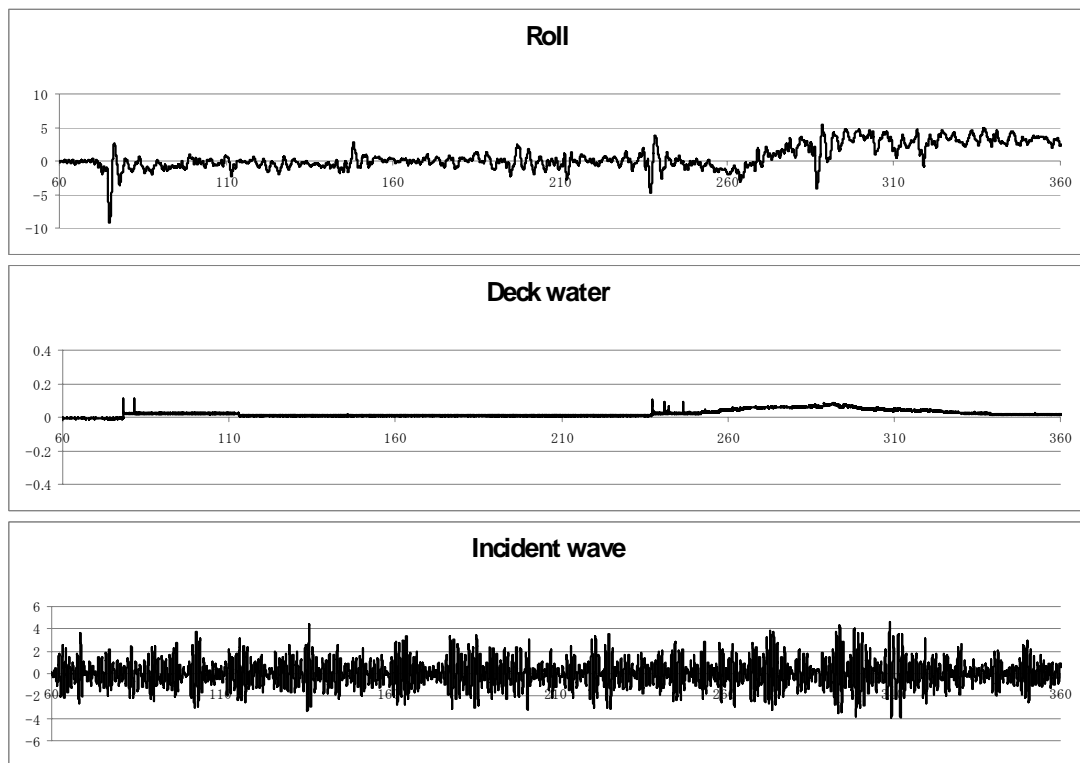
Figure A2 – Sample of time history of roll motion, water height on ro-ro deck and incident wave (GM:1.2 m, Significant wave height :4 m)

5 Figure A2 shows the example of time histories of roll motion, water height on ro-ro deck and incident waves. In the case of GM=1.2m, it is clarified that the present RoPax ferry did not capsize in different ten 30 minutes realizations although water piled up on ro-ro deck and induced the certain heel to lee side. In the meanwhile, in the case of GM=1.0m, ship capsized because GM after damaged became almost zero. Therefore, it is clarified that the required GM exists between 1.0 m and 1.2 m.
